## 2.0 TFSI Pressure Control Valve PCV Delete Removal Bypass Repair Unit Kit Install Instructions

by x8rltd

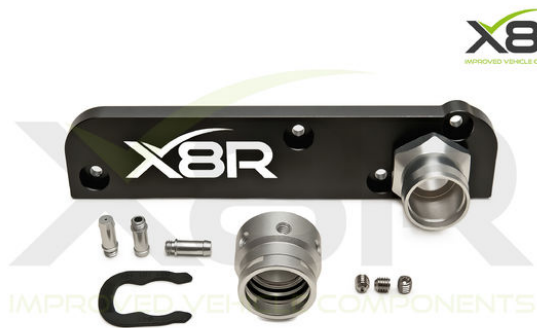
**You will receive**

Billet Black Anodised Aluminium Valve Cover Plate

Billet Silver Anodised Aluminium PCV Adapter

Billet Silver Anodised Aluminium Manifold Cap

Our beautifully machined billet anodised aluminium unit (check our feedback for the quality of our manufacturing). Directly replaces the PCV unit deleting the OEM PCV system. Removing the original flawed design part from the engine.

Our unit links the two internal ports together, this emulates what happens inside the OEM PCV when the engine is on boost, but removes the fragile components which commonly fail.

Our kit also includes a blank for the inlet manifold. This is engineered with three ports, where either our vacuum nipples can be fitted (included in kit) to run a boost gauge or water spray controller or these can be blanked off (blanks included).

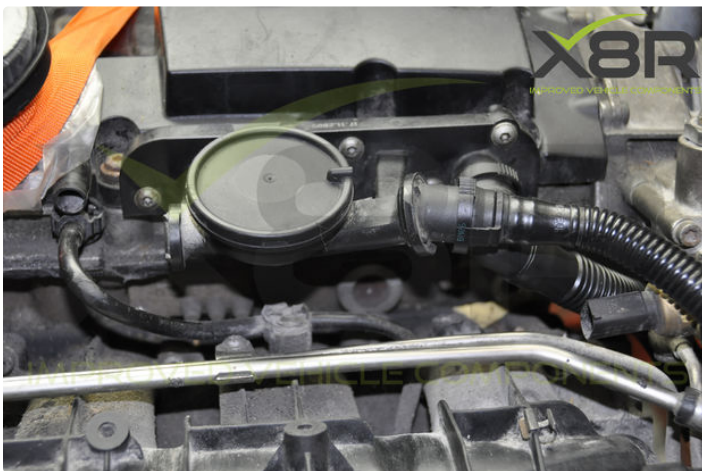
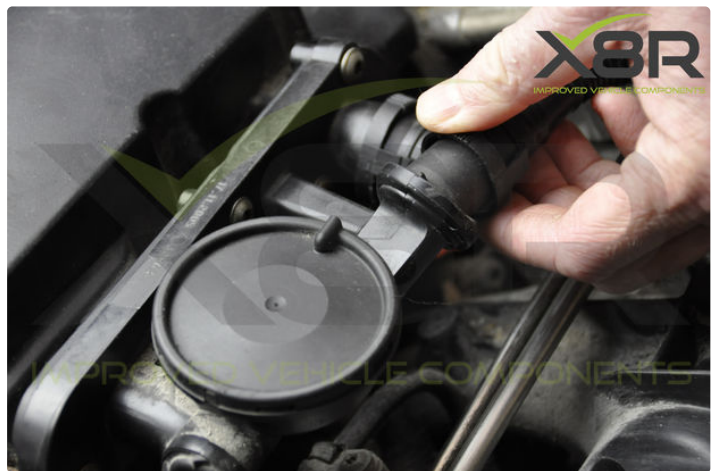
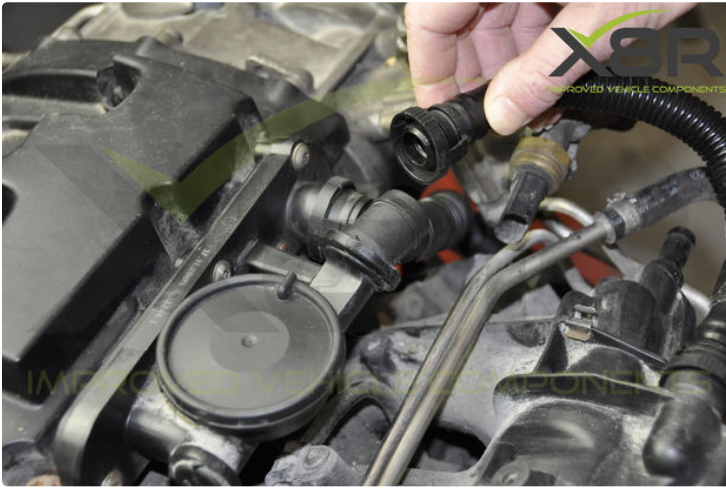
### Step 1: Remove PCV Pipe From PCV Unit

Push in the knurled tabs each side of the pipe connector and pull the pipe loose from the PCV unit.

Make sure to only pull on the pipe connector, the pipe might be brittle and putting pressure on that can cause it to crack.

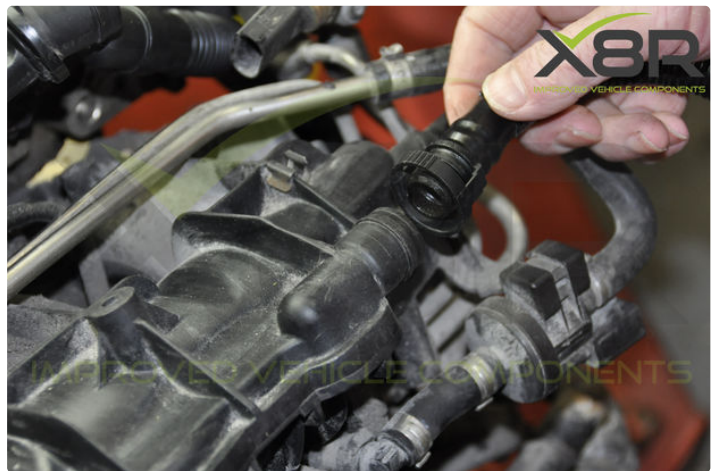
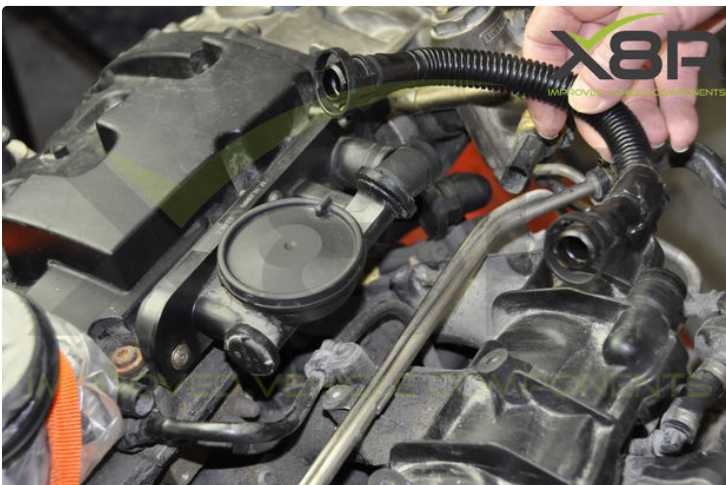
## Step 2: Remove PCV Pipe From the Intake Manifold

Remove the other end of the PCV pipe. Push in the knurled tabs each side of the pipe connector and pull the pipe loose from the intake manifold.

Again make sure to only pull on the pipe connector, the pipe might be brittle and putting pressure on that can cause it to crack.

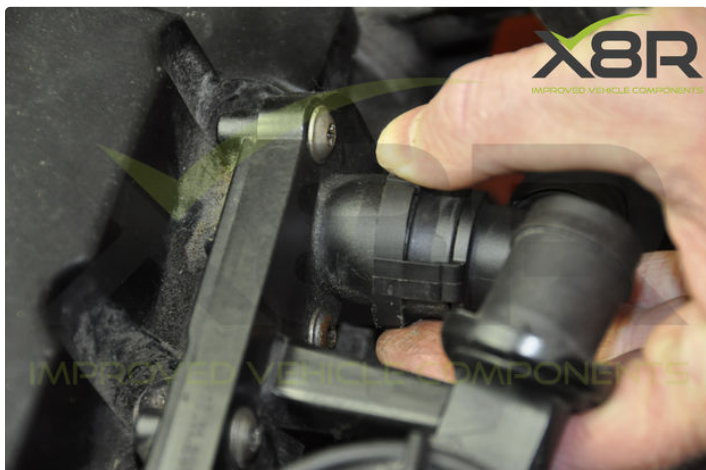
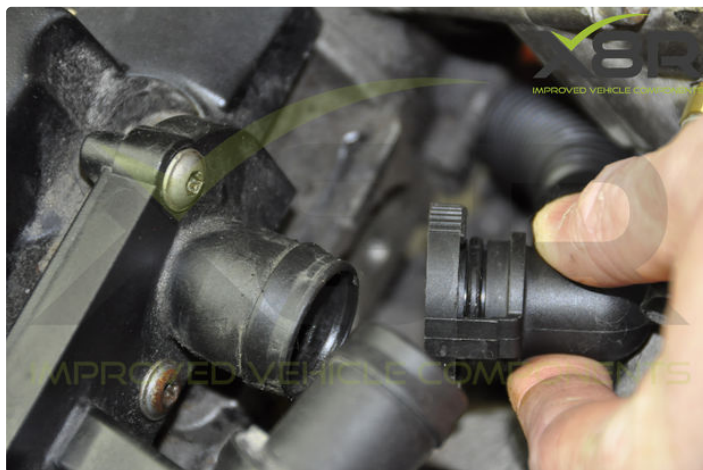
### Step 3: Remove Lower Pipe From PCV Unit

Repeat as before and remove the lower pipe from the PCV unit.

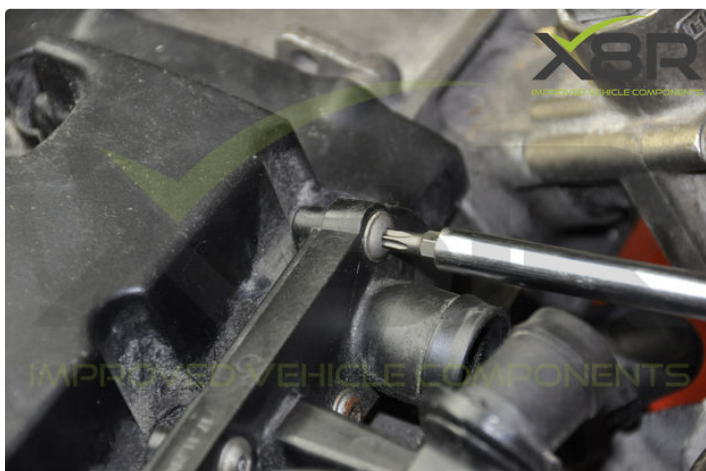
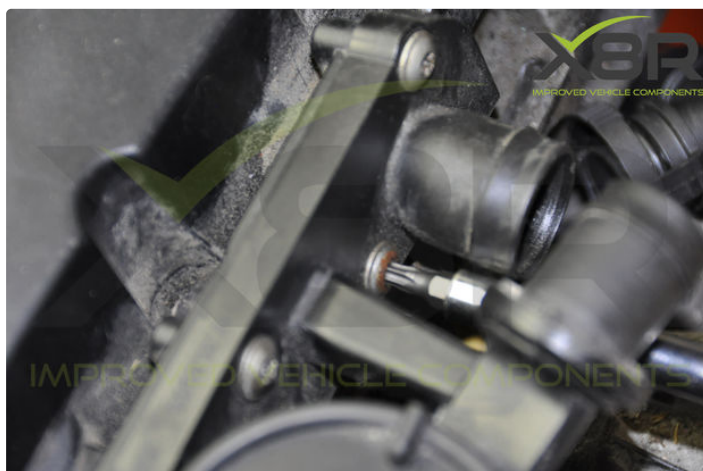
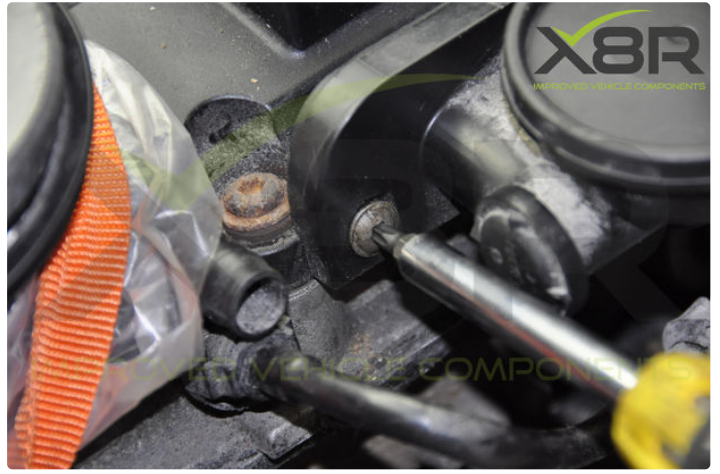
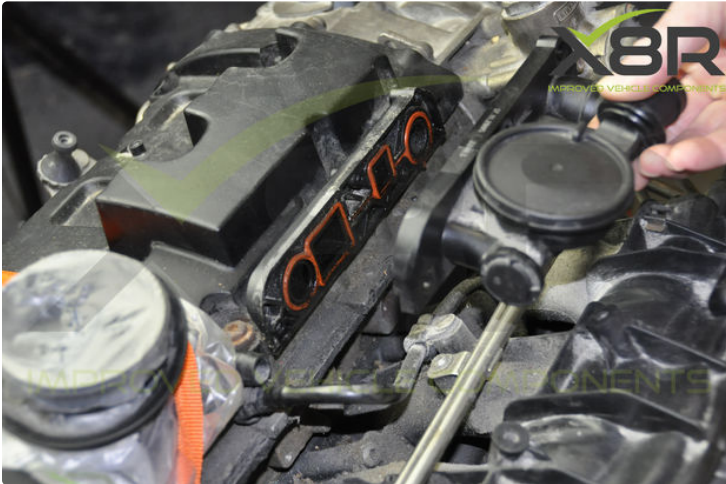
### Step 4: Remove the PCV Unit From the Valve Cover

Using a T25 screwdriver remove the 4 screws from the PCV unit and remove the PCV unit.

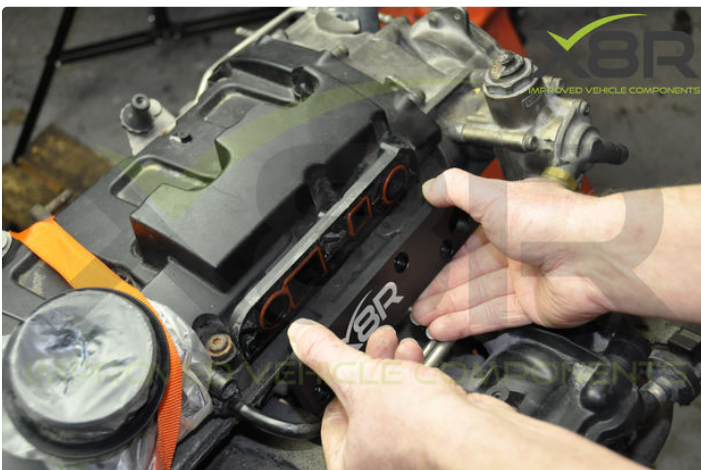
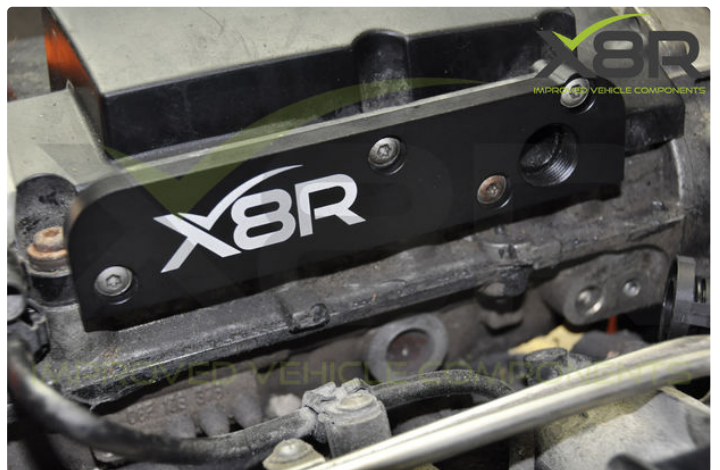
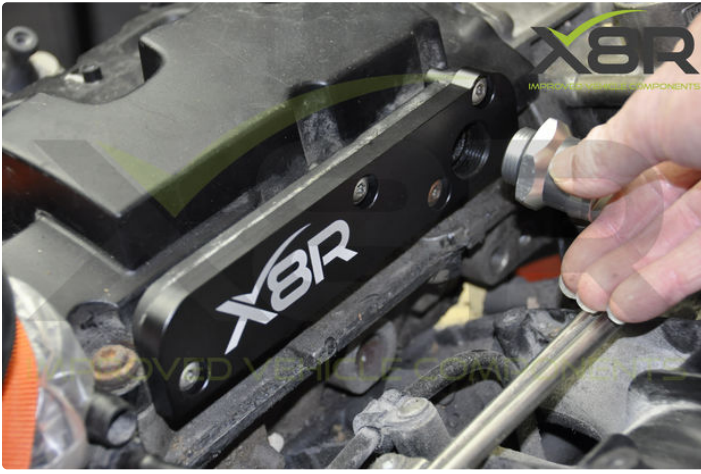
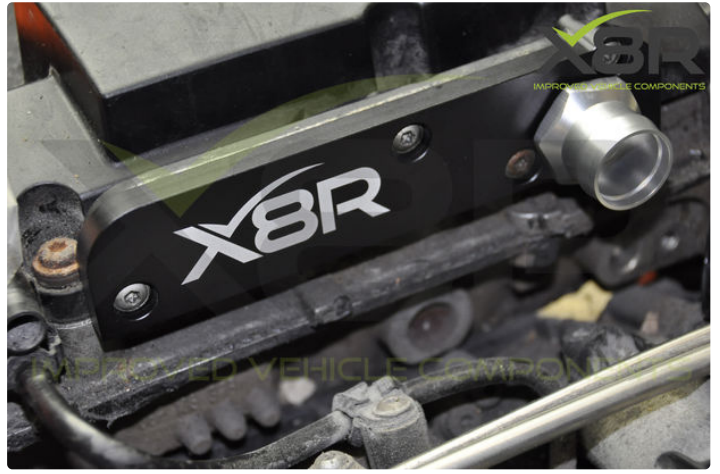
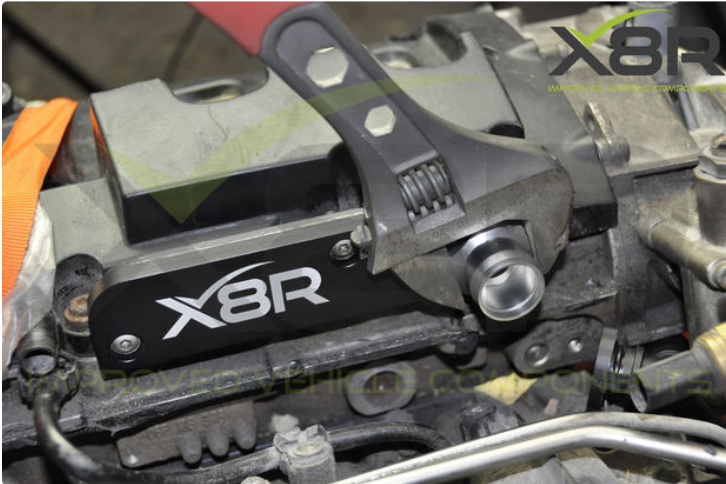
## Step 5: Fit Our PCV Delete Plate

Fit our PCV delete plate, mount using the 4 screws removed in the previous step.

Screw the pipe adapter on to the delete plate and tighten with a spanner. This part seals on an O-ring so should not be over tightened.

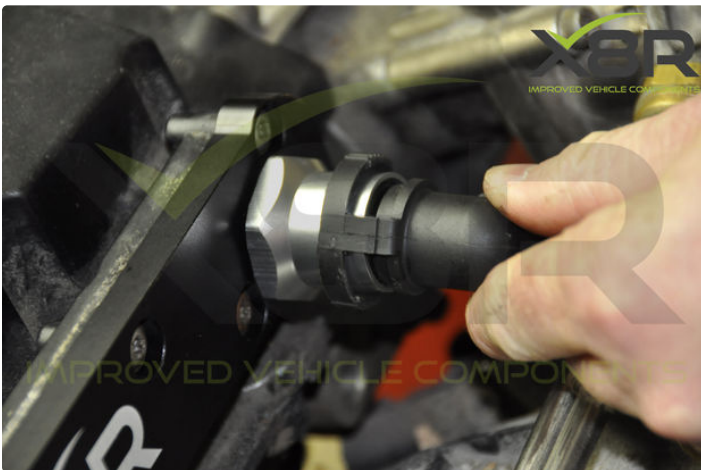
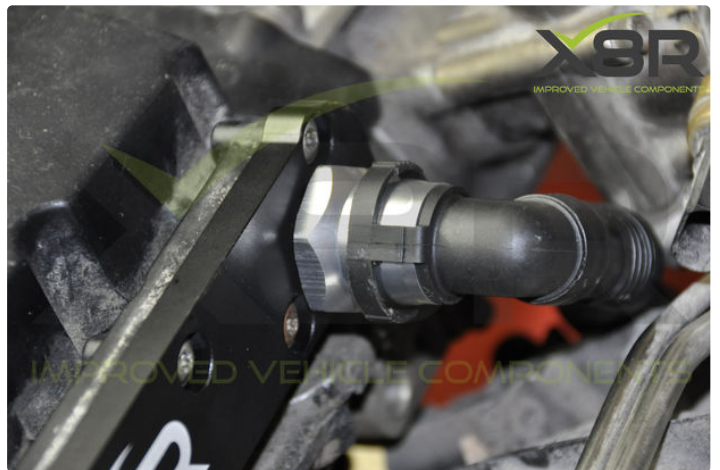
### Step 6: Connect Lower Pipe to the Delete Plate Adaptor

Push fit the lower pipe connector to the delete plate adapter.

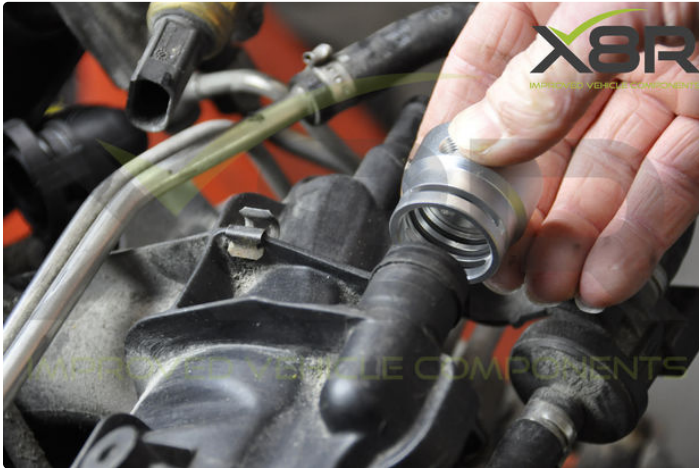
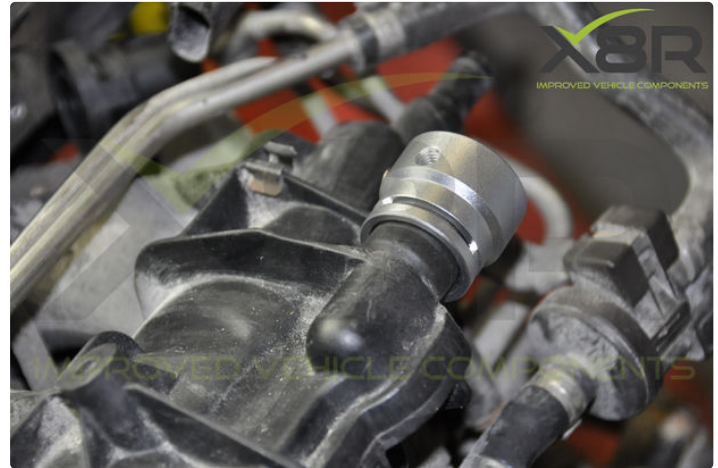
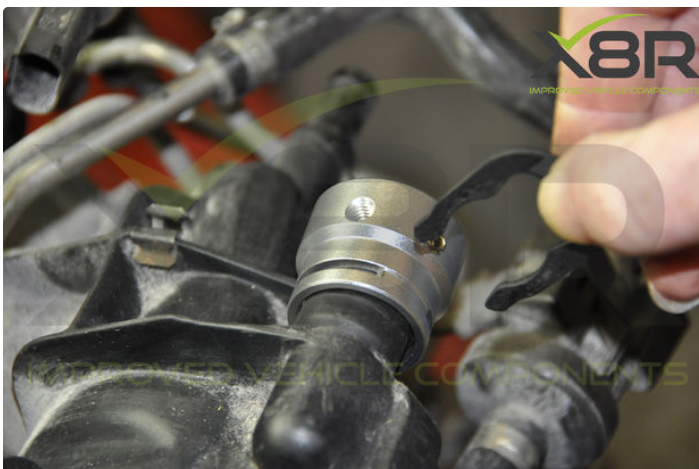
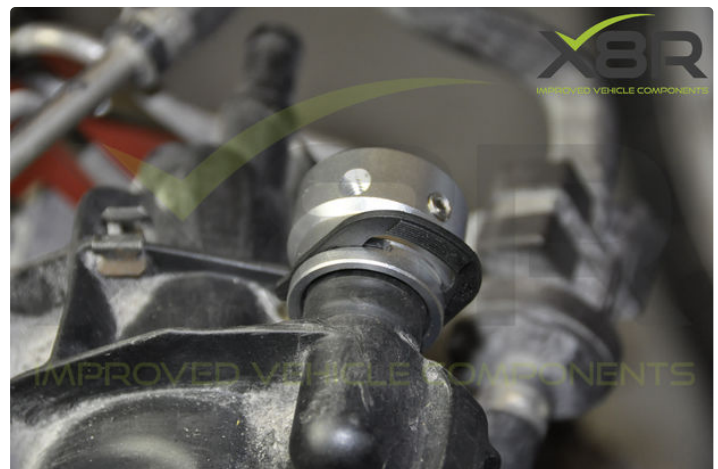
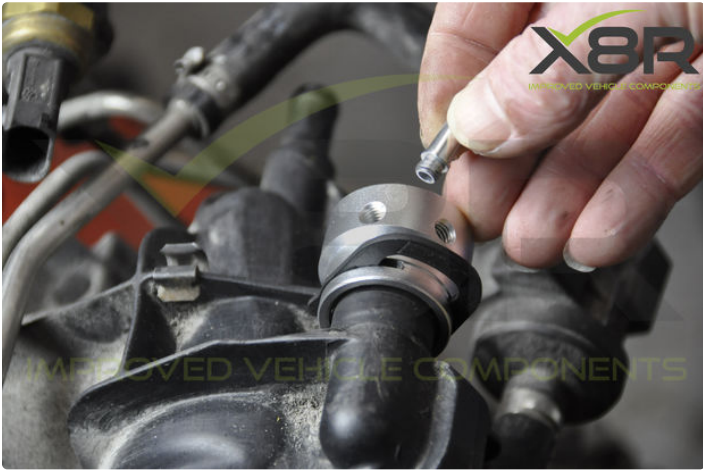
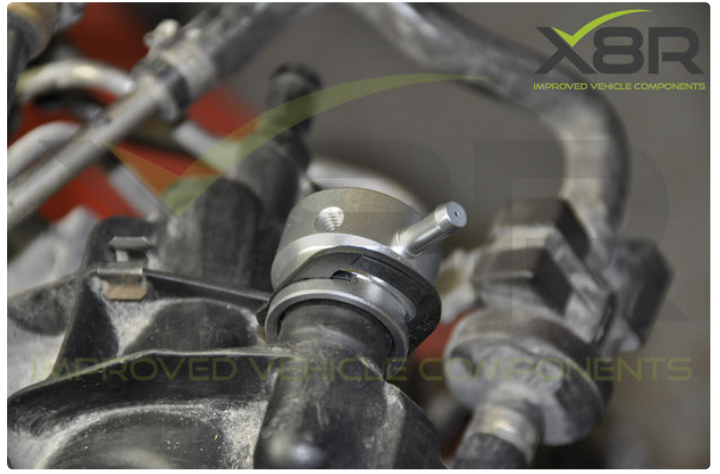
## Step 7: Fit Our Intake Manifold Cap

Push our intake manifold cap on to the intake manifold as shown.

Push until fully engaged on the manifold and insert the clip to retain.

On the blank is three threads, included in the kit is three vacuum nipples and three blanking screws. You can decide which to fit depending on if you want to run any gauges. We recommend using thread lock or sealant on the nipple threads or blanking screws.
