# Renault Sport RS Clio II Mk 2 172 182 Steering Wheel Rubber Replacement Thumb Grips Install Instructions Fitting Guide

## **Intro:** Renault Sport RS Clio II Mk 2 172 182 Steering Wheel Rubber Replacement Thumb Grips Install Instructions Fitting Guide

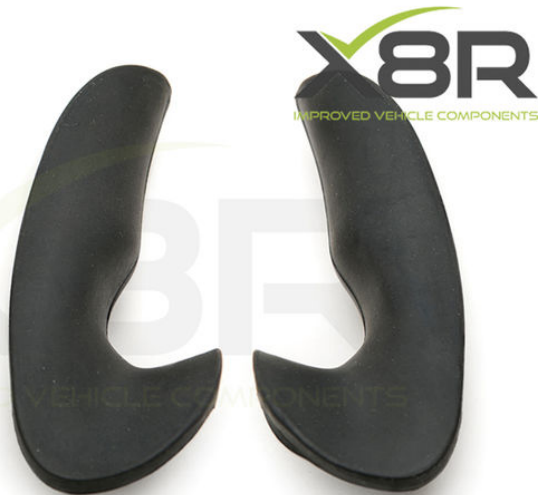
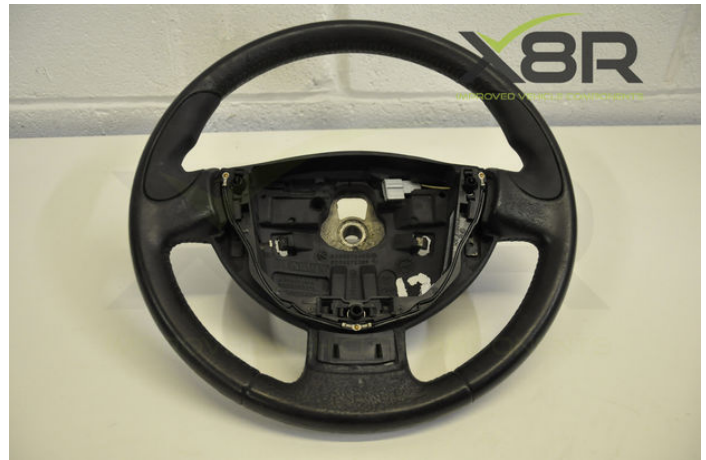
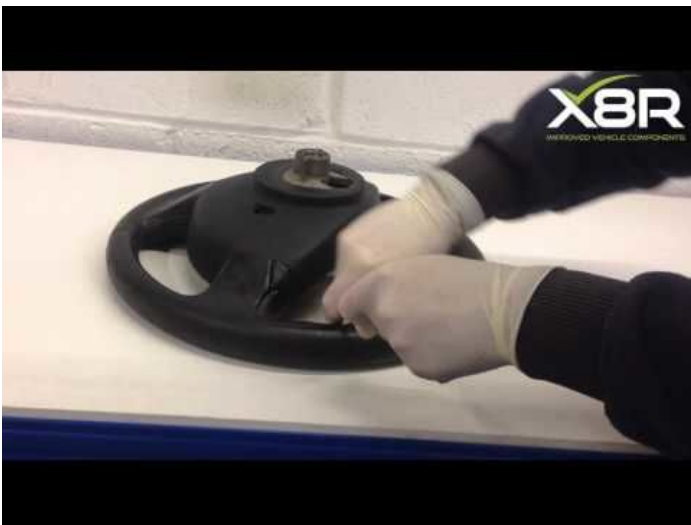
Steering wheel rubber thumb grips worn, melted, damaged, disintegrated or split spoiling the look and feel of the steering wheel.

**The rubber steering wheel thumb grips wear / melt ruining the look and feel of the steering wheel.**

It is very common for the thumb grips on the steering wheel of Renault Sport models to deteriorate and ruin the look of the steering wheel and the vehicles interior as a whole. The original thumb grips are made from a poor quality rubber and deteriorate quickly when toughed or exposed to sunlight / heat. Until now the only solution has been to replace the steering wheel for new at vast expense, unfortunately the grips on the OEM steering wheel just deteriorate again.

**Fit our replacement thumb grips and improve the look of the steering wheel instantly.**

Our replacement grips can be fitted extremely easily and will improve the appearance and feel of the steering wheel instantly. Molded to the exact shape of the original part these grips are a perfect fit. Simply cut away the old grips and glue our new grips in to place, please check out our instructions and videos showing how to do this, there is no need to remove the steering wheel to repair. Our grips are molded from a tougher rubber than the originals, we made a conscious choice to make these from rubber as they maintain the original look / comfort of the original part which plastic or carbon items at a much higher cost fail to do.

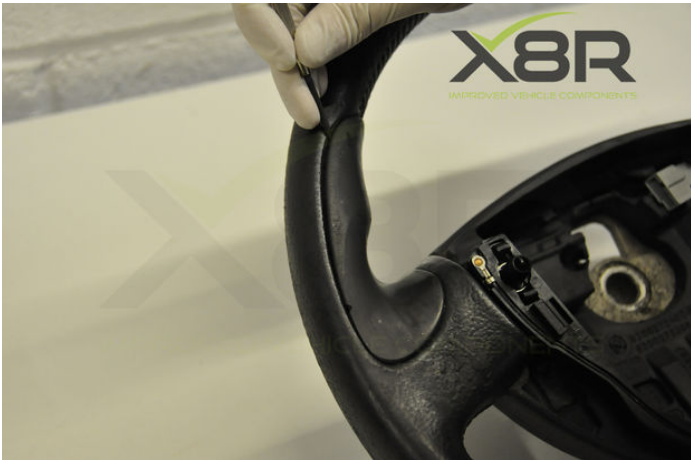
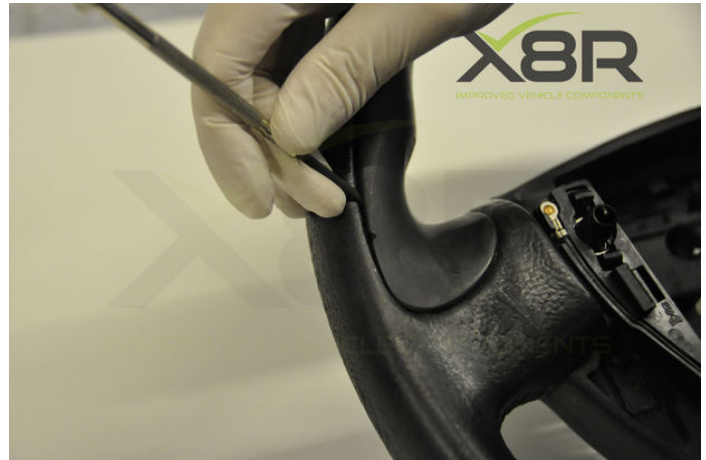
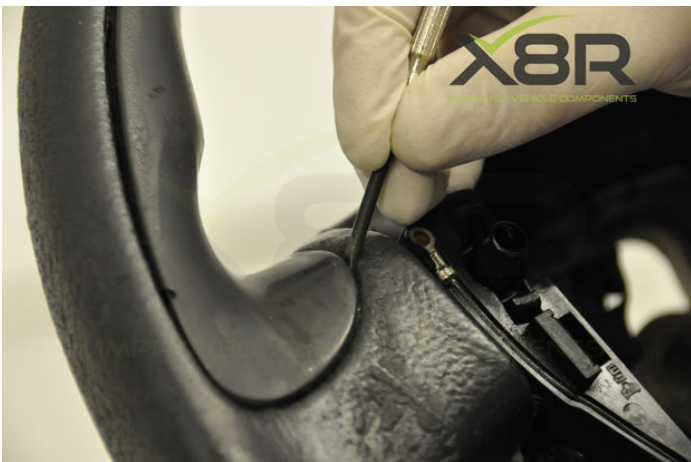
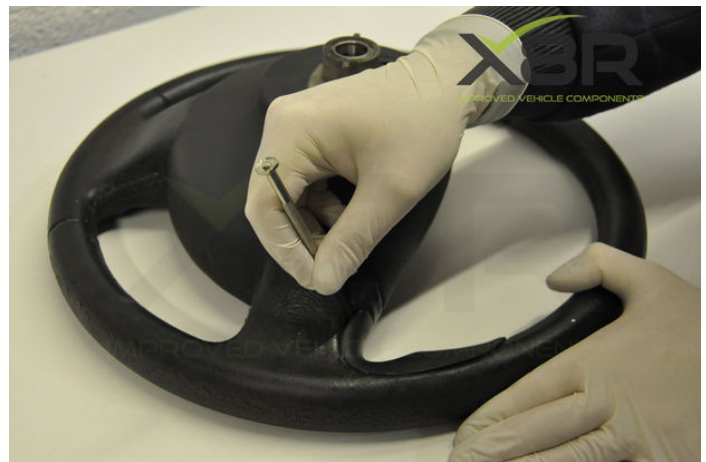
### Step 1: Remove the old thumb grip

- Start by removing the old thumb grip from the steering wheel using a small flat bladed screw driver or pick.
- Slot the pick or screw driver in the gap between the thumb grip and the steering wheel, taking care not to damage the steering wheel.
- Pry back the remains of the original thumb grip until it starts to lift, then work your way around the grip and remove it slowly.

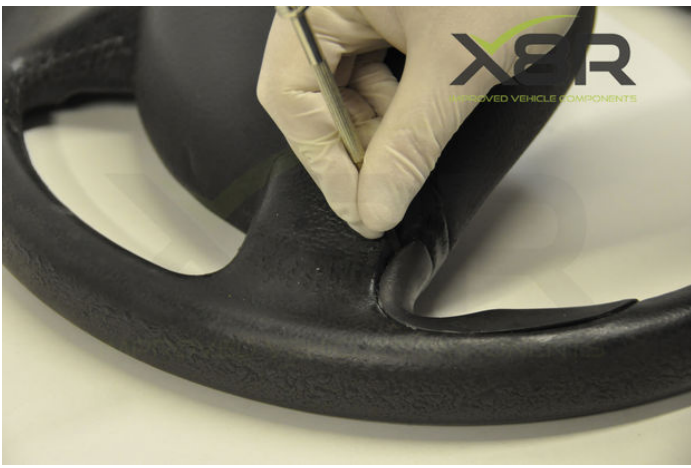
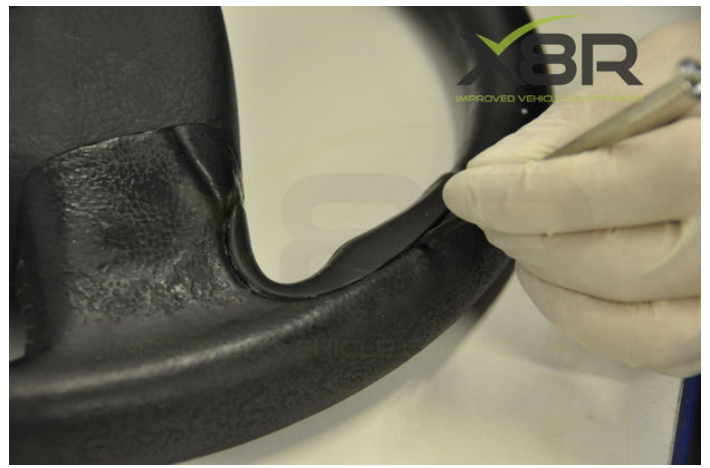
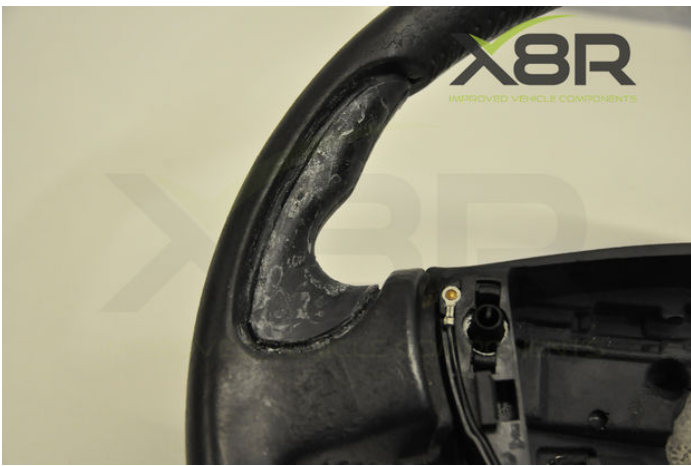
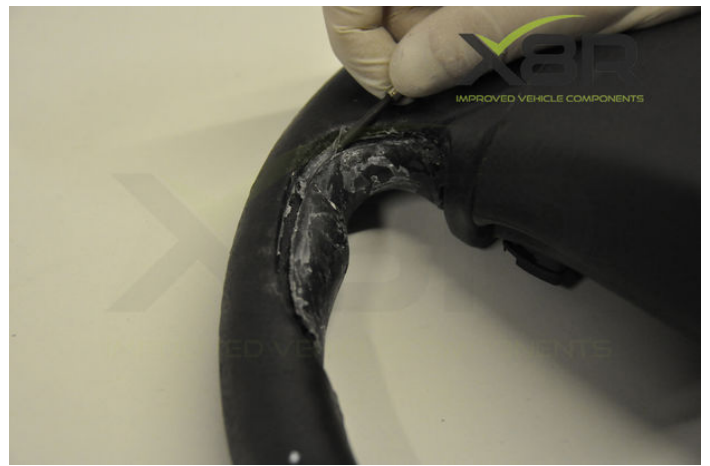
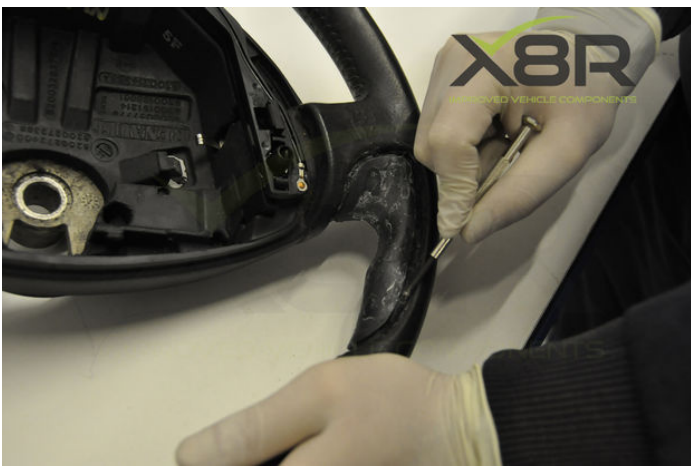
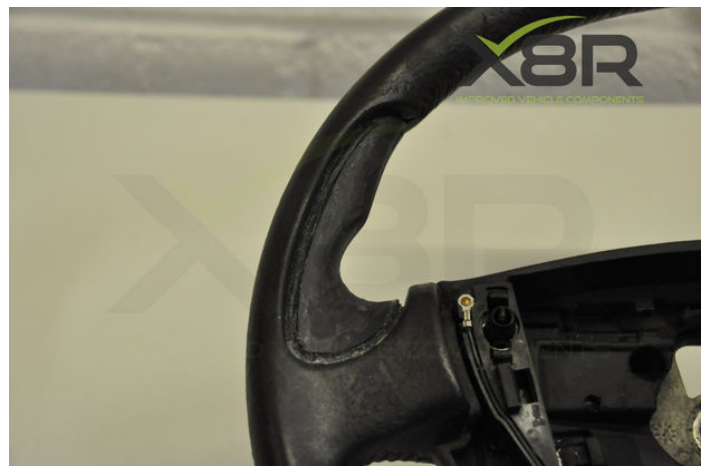
**Step 2: Remove the remnants of the old grip and glue**

- Using a flat bladed screw driver pick out any leftover remnants of the old grip or glue - both of which will need to be removed to allow the new grip to seat correctly.

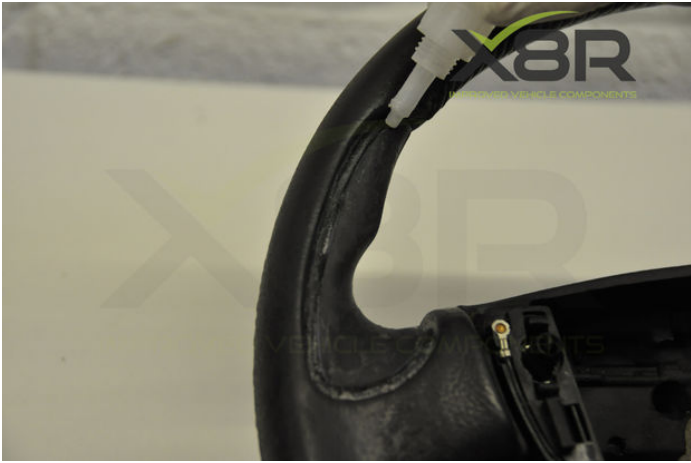
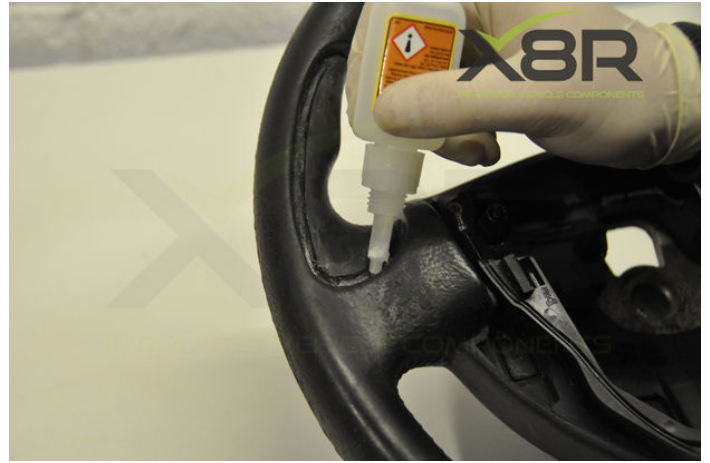
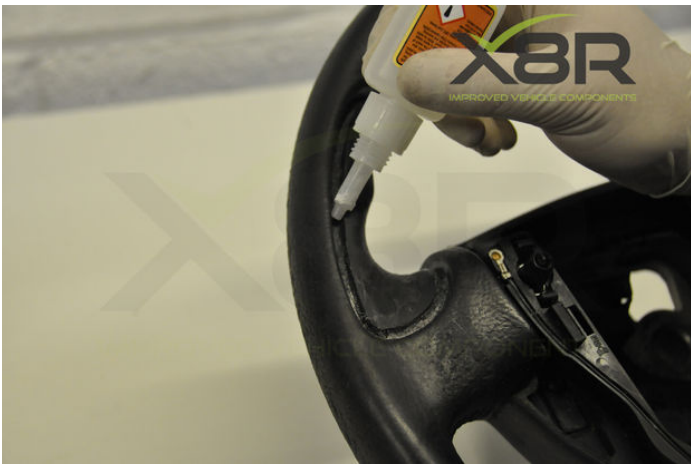
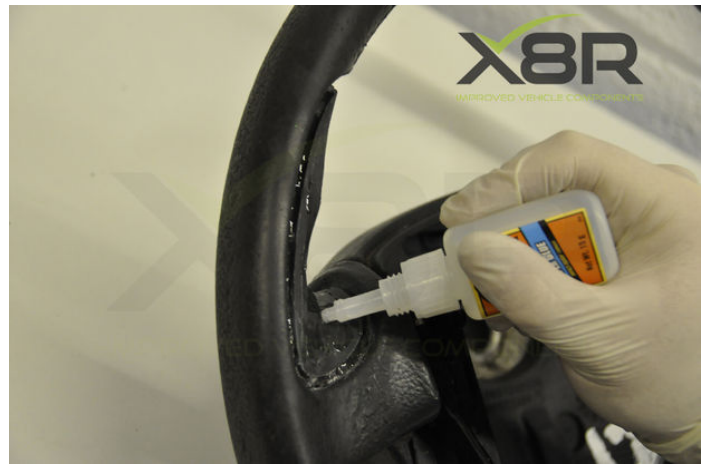
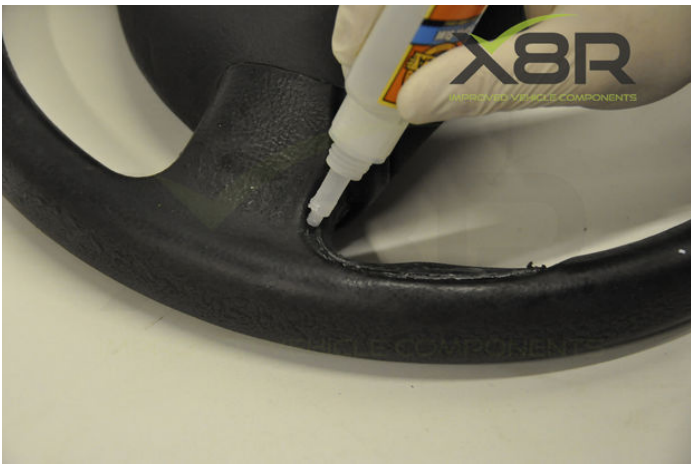
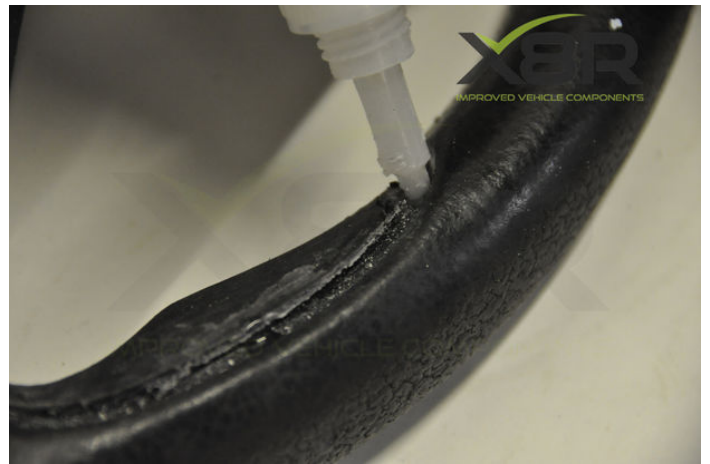
### Step 3: Apply glue

- Apply glue in the groove of the steering wheel, running the glue all the way around the groove and the center part of where the grip sits (as shown in the images) - making sure to keep away from the leather part of the steering wheel.

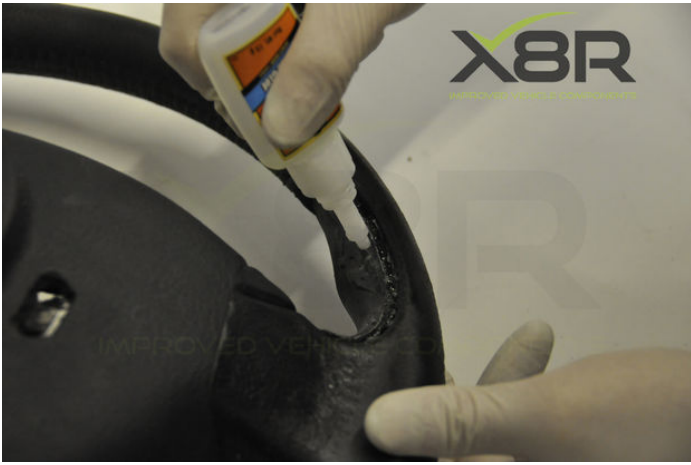
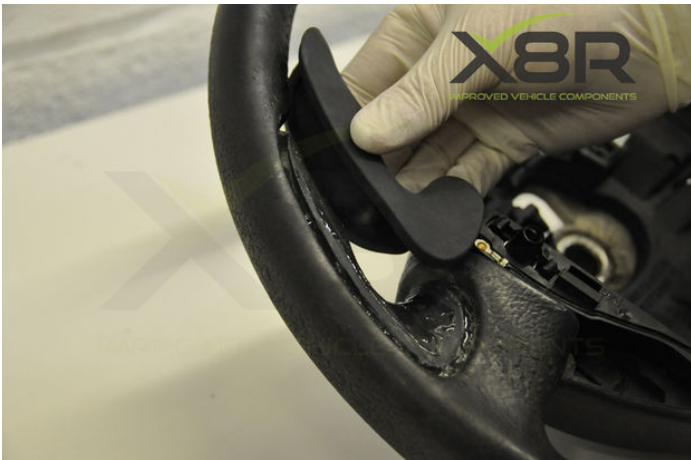
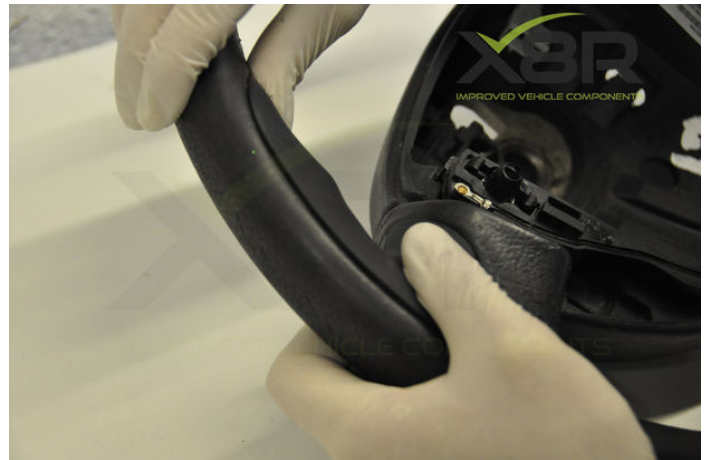
#### Step 4: Fit the new grip

- Offer up the new grip to the steering wheel
- Make sure the thumb grip is sitting correctly on the front and back
- Once you're happy with the way it's seated on the steering wheel, hold in place for up to 30 seconds to allow the glue to set.
- Repeat this process for the second grip.
