Vauxhall Vivaro, Renault Trafic, Nissan Primastar Gear Shift Selector Linkage Cable Repair Fix Instruction Guide

Intro: Vauxhall Vivaro, Renault Trafic, Nissan Primastar Gear Shift Selector Linkage Cable Repair Fix Instruction Guide

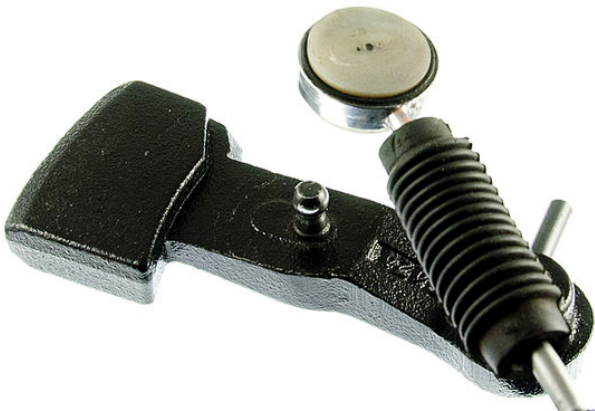
Fit our clamp on to the bush end and tightly secure the cable to the ball joint for life.

Our unique design item securely clamps the selector cable bush to the gear box and will not wear. Restore smooth gear selection for good. Our item features a dual clamp design so there is no possibility of the joint working loose. A strong sleek design finished in mirror polished stainless steel. Fitment is very simple and can be carried out in situ under bonnet.

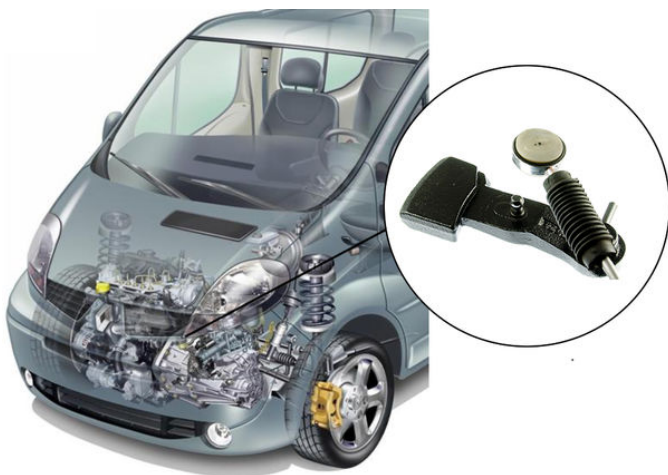
Step 1: Locate linkage

The gear selector cable bush end has worn and popped off of the ball joint on your gear box.

Open bonnet and look down to gearbox, you will see the loose cable in the location illustrated.
