Mercedes Comand Controller Rotary Wheel Scroll Knob Switch Button Unit Shaft Repair Fix Kit Install Instructions Guide

by x8rltd

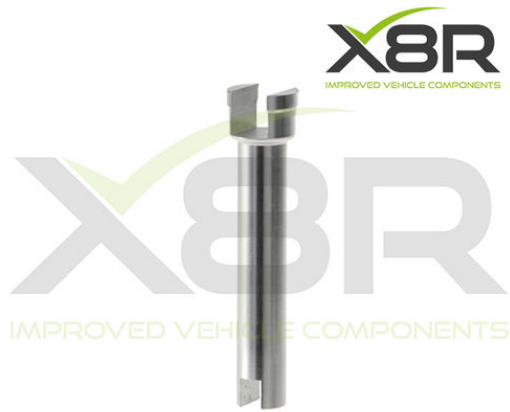
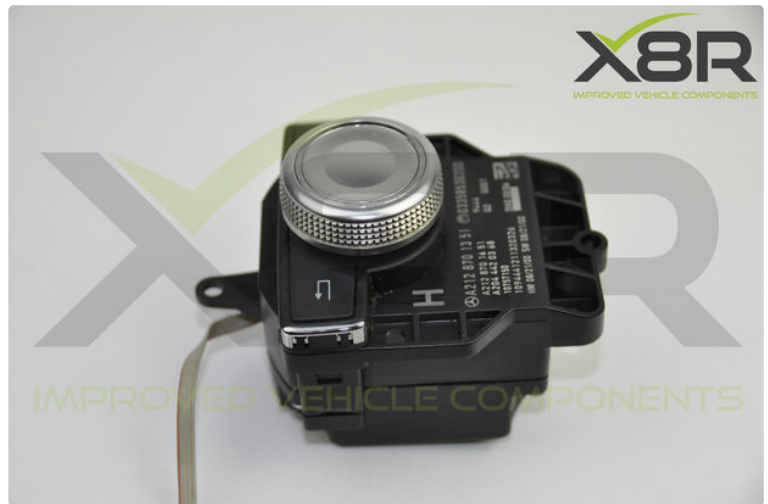
Restore full function with our replacement metal shaft.

Our part allows you to replace just the shaft within the knob unit which fails, without having to replace the complete unit at vast expense which would just fail again. Our shaft is CNC machined from billet aluminium then anodised. Beware of 3d printed, plastic and cast metal parts which could fail again. Our part will last the life of the vehicle. Using our part replace just the component that fails with an improved design part and restore full function permanently.

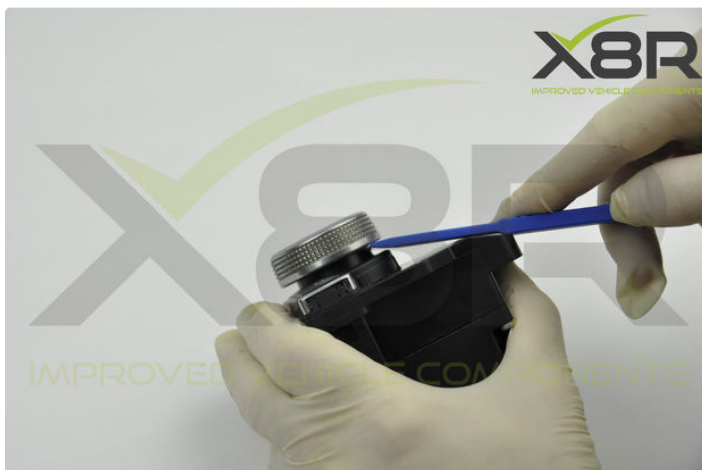
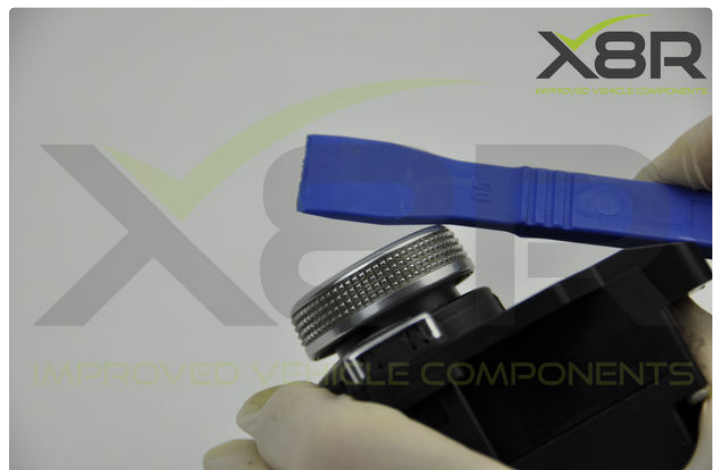
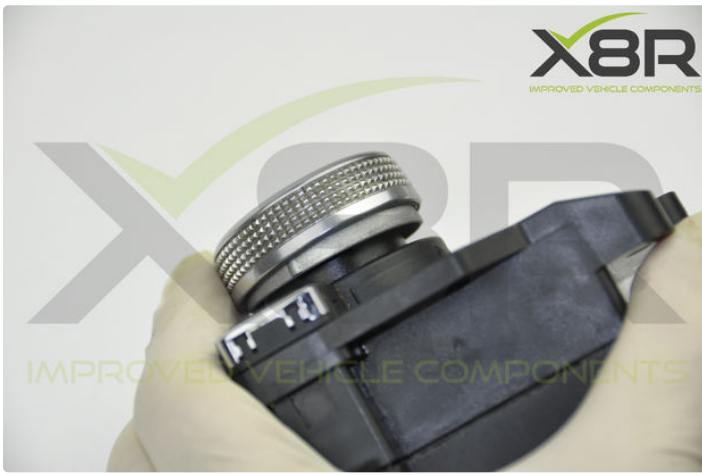
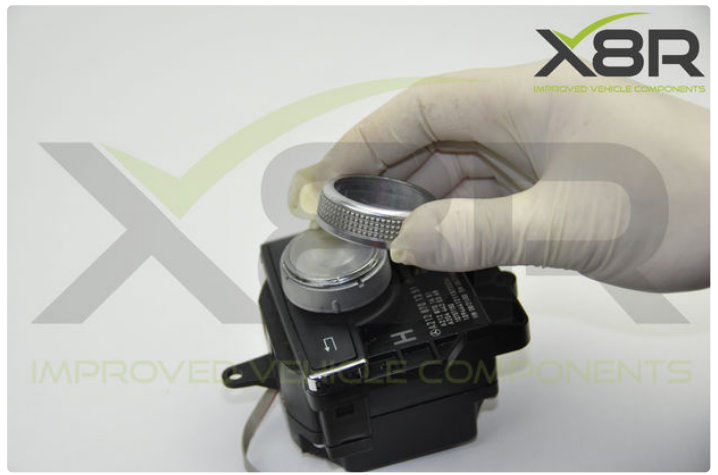
Step 1: Lever Off Outer Part of Dial

Using a plastic screwdriver or pry tool; lever under the edge of the outer part of the dial as shown.

Lift this gently and in increments, push down on the center button of the dial to resist the lifting movement on the outer part of the dial.

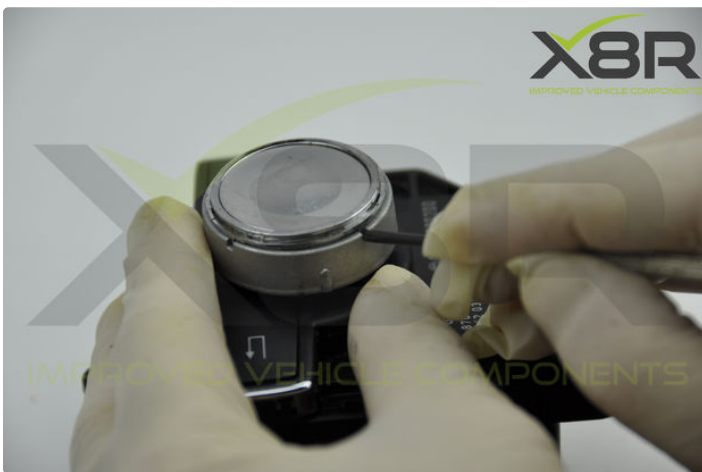
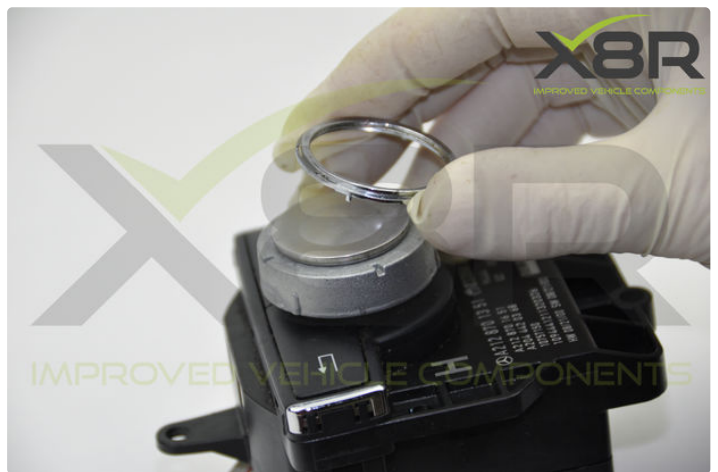
Step 2: Remove Top Ring

Using a small screwdriver or pick, inset as shown and lift the top ring from the dial.

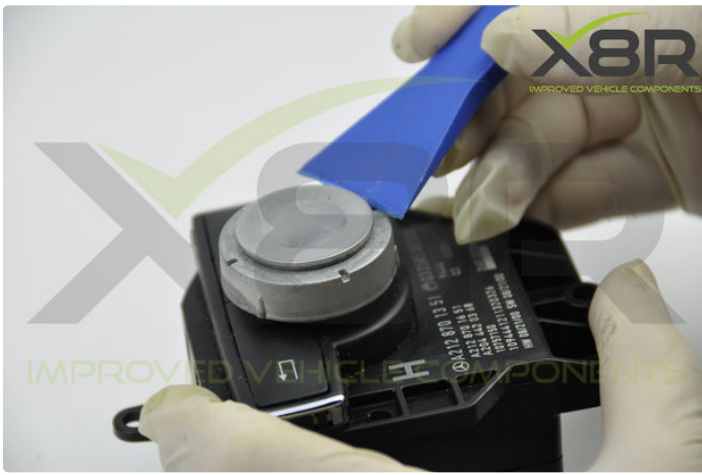
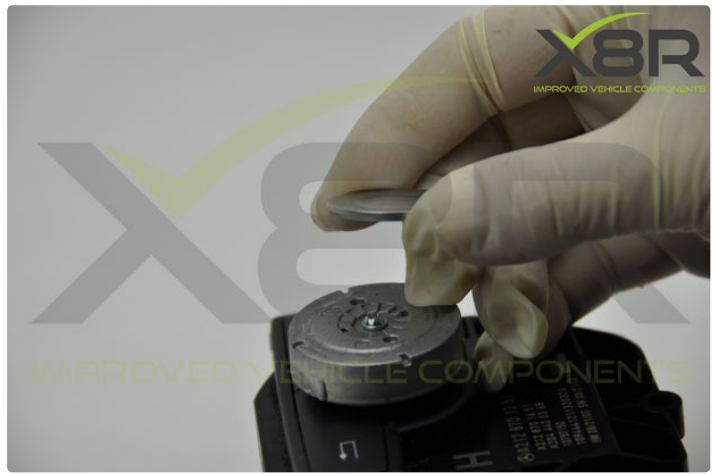
Step 3: Remove Top Button Cover

Using a plastic pry tool or screwdriver; slide under and lift off the top button cover.

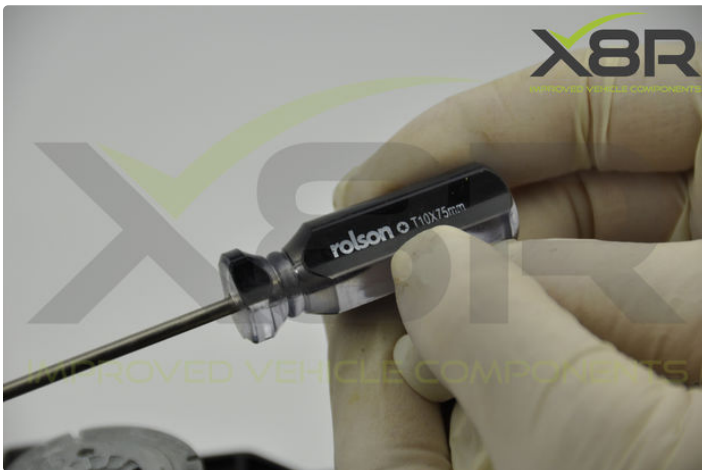
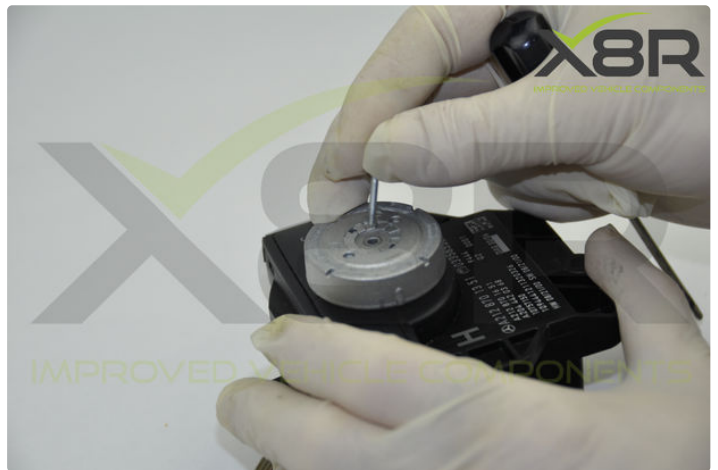
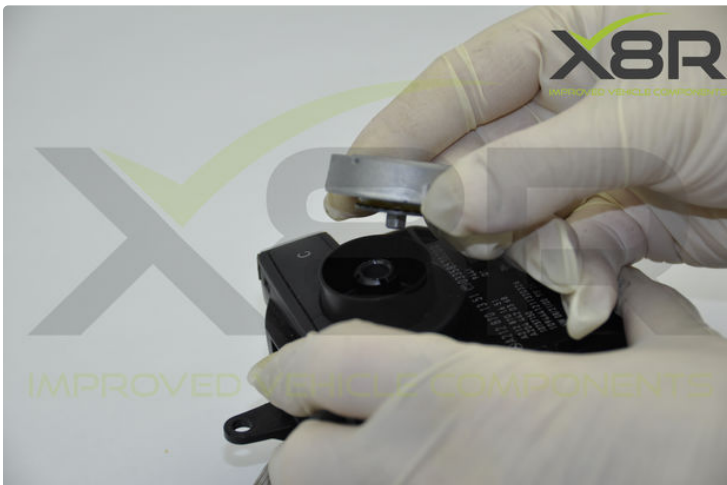
Step 4: Remove Dial

Using a T10 Torx screwdriver loosen the screw and lift off the dial.

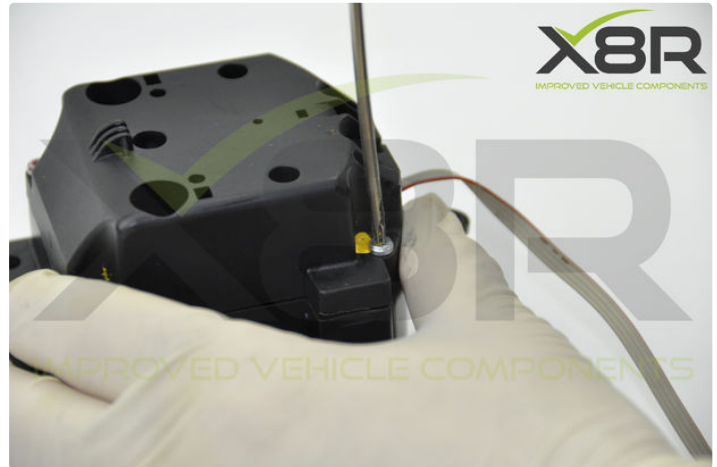
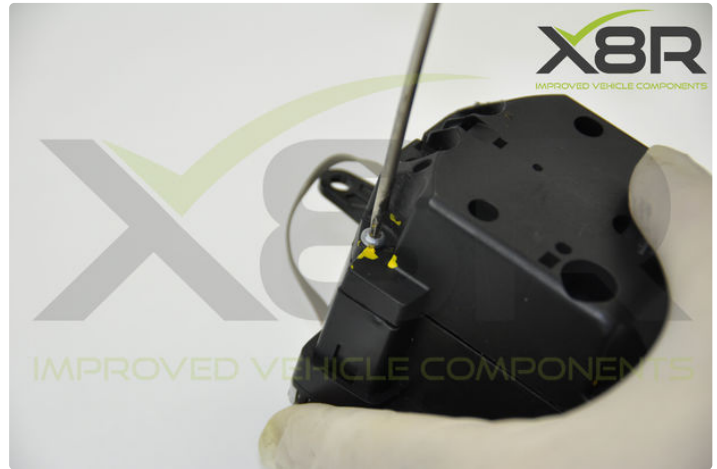
Step 5: Remove Screws

Using the T10 screwdriver remove the 4 screws as shown.

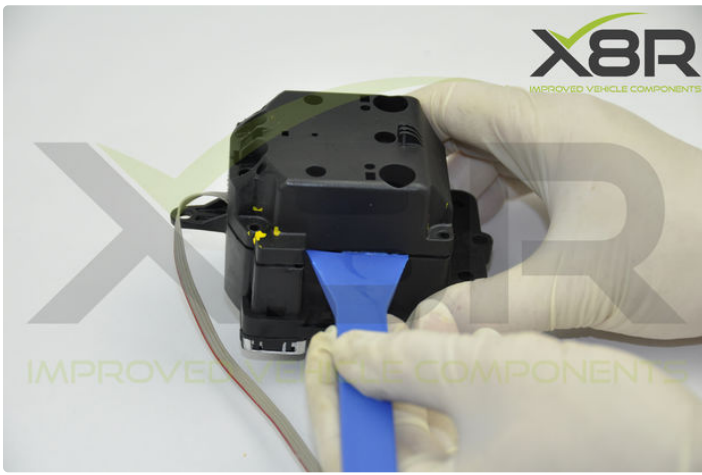
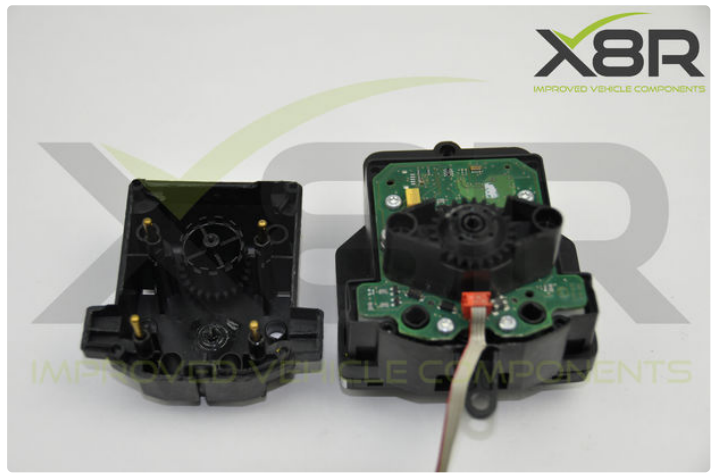
Step 6: Separate the Two Sections of the Unit

Using plastic pry tools separate the two halves of the unit.

Around the center of the unit you will be able to see the joint of the two halves of the unit. Again gently and in increments level the two halves apart.

Take care not to damage the electrical ribbon which locates between the two halves.

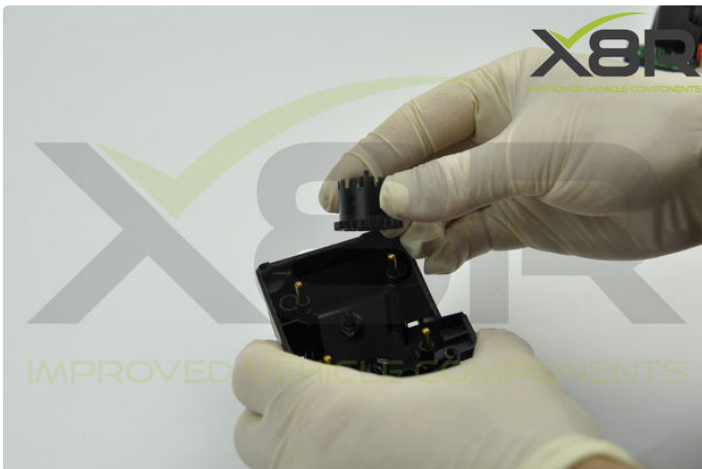
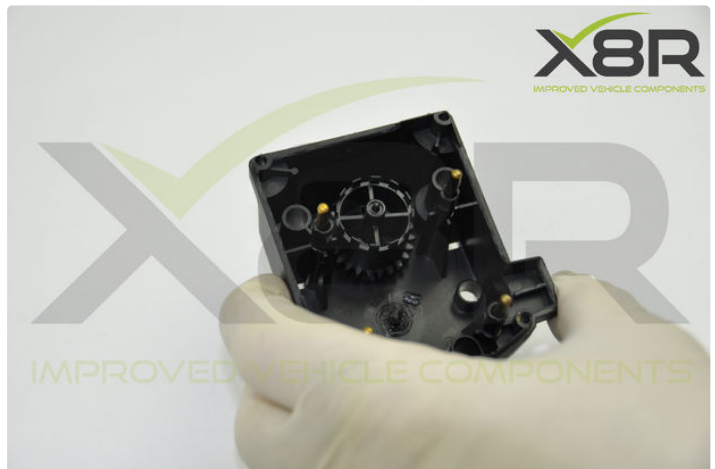
Step 7: Locate the Plastic Gear

When separating the two halves of the unit this plastic gear shown may move out of position. Please note its correct position and orientation as shown.

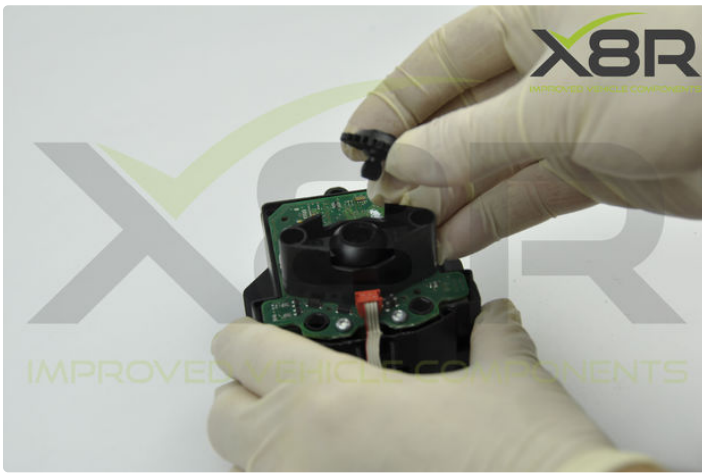
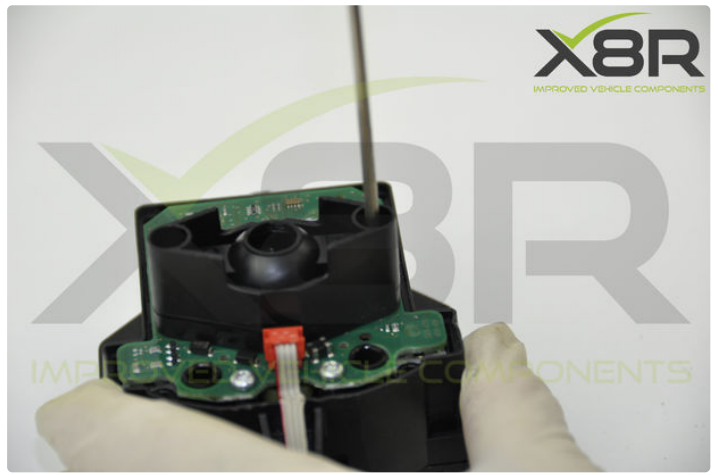
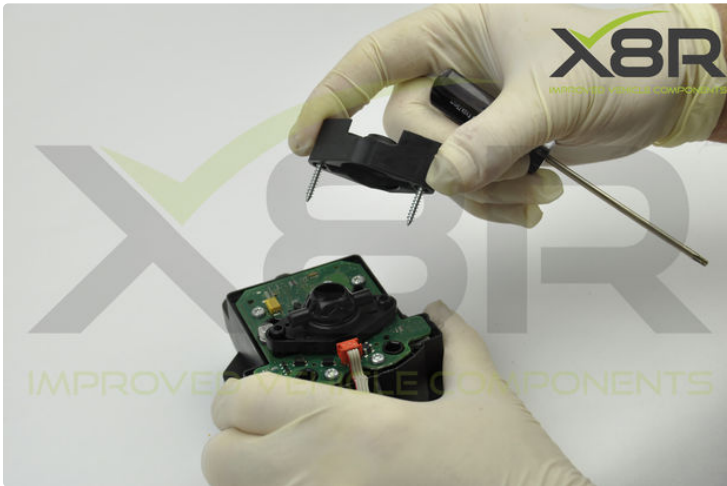
Step 8: Remove Shaft Housing

Remove the plastic gear from the top of the shaft housing as shown.

Using the T10 screwdriver loosen the two screws on the housing and lift out of position.

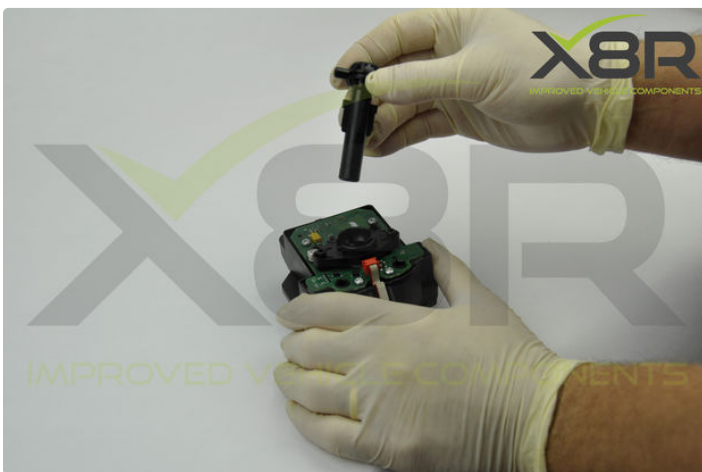
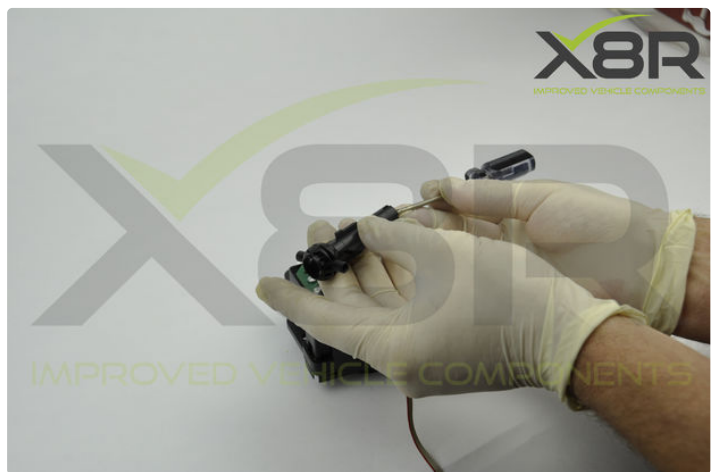
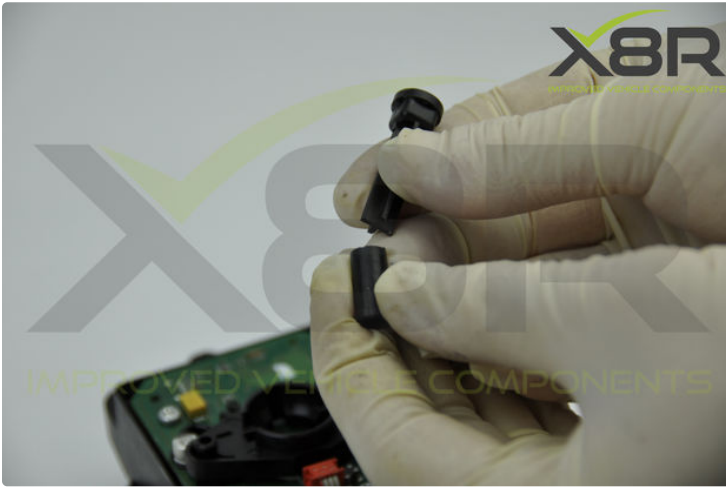
Step 9: Remove the Shaft

Lift the black plastic shaft out of position.

The broken spindle is within this part.

Tip the shaft on its end and push out the two broken pieces of the spindle using the screwdriver.

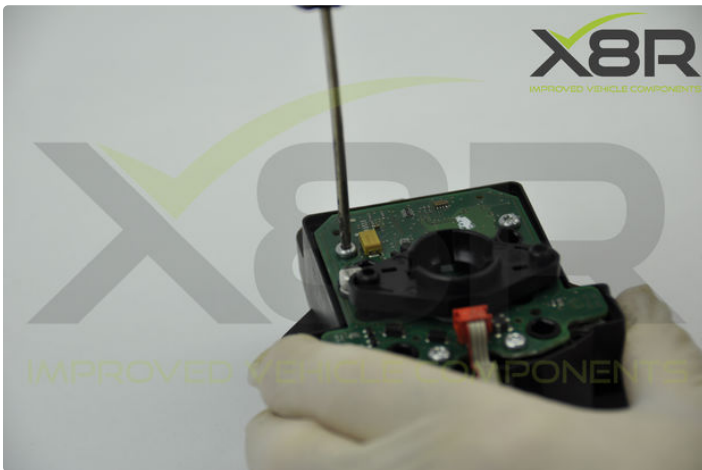
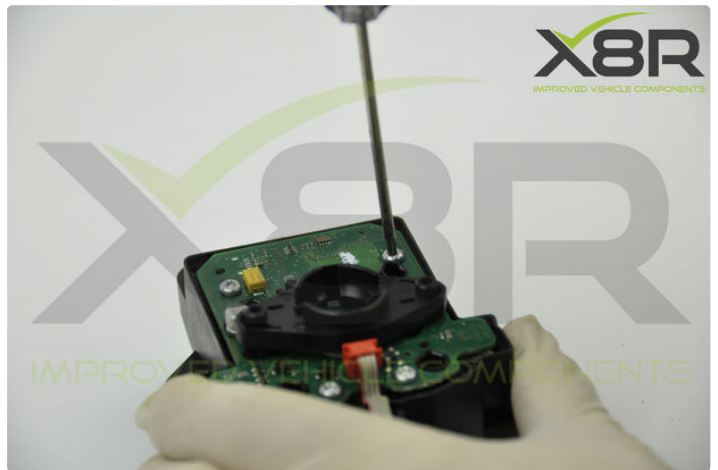
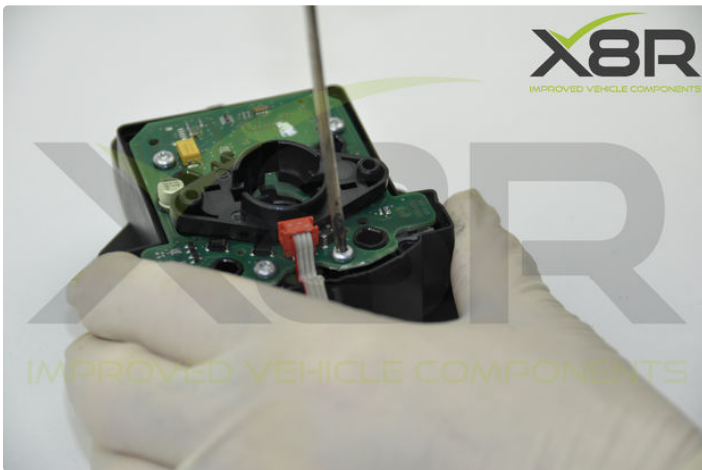
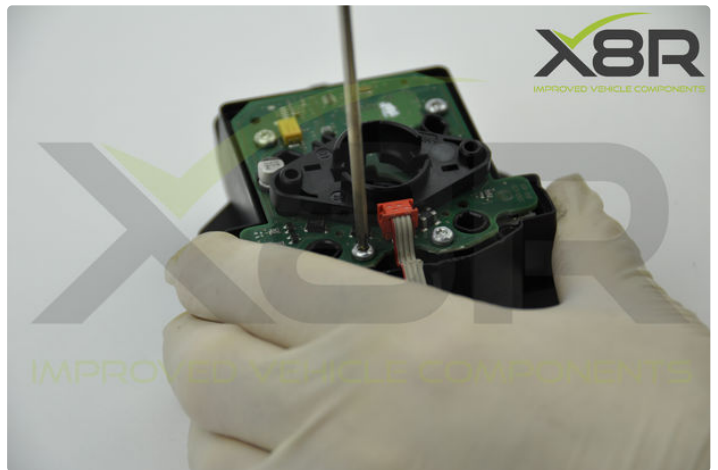
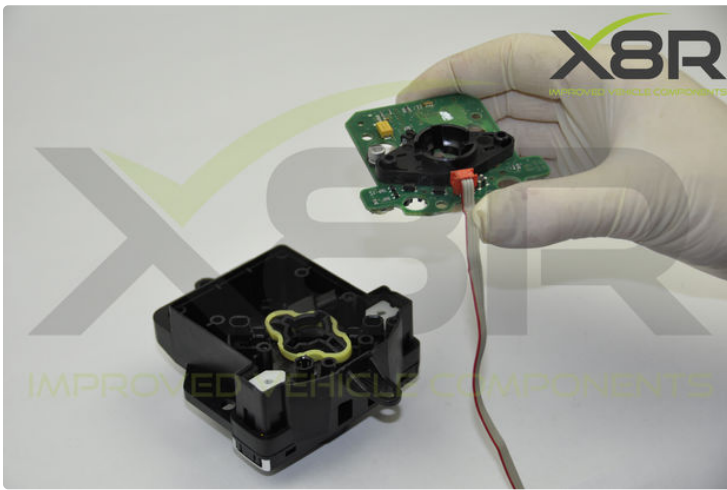
Step 10: Remove the Circuit Board

Remove the 4 screws as shown and gently lift the circuit board out of position.

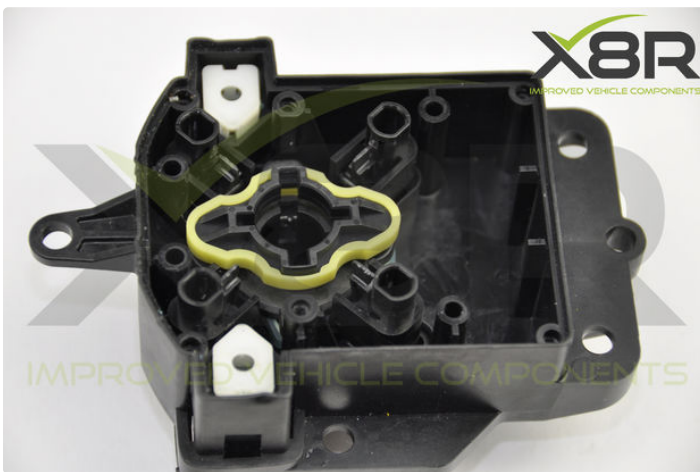
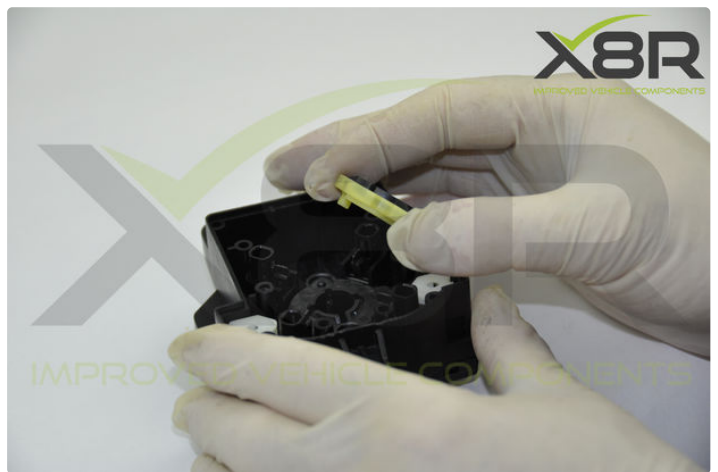
Step 11: Remove the Plastic Bush

Remove the plastic bush as shown.

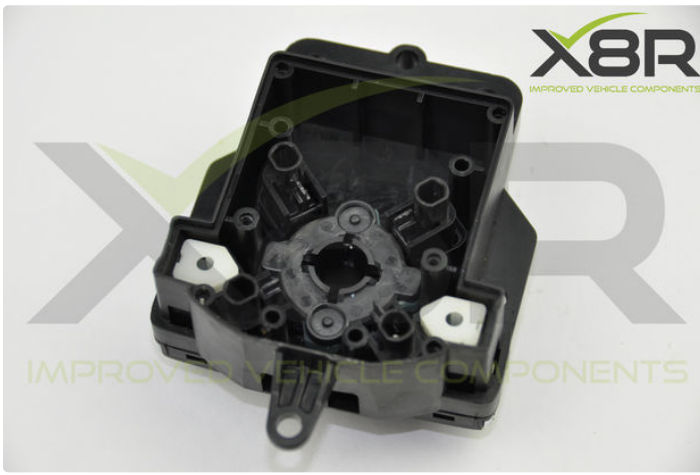
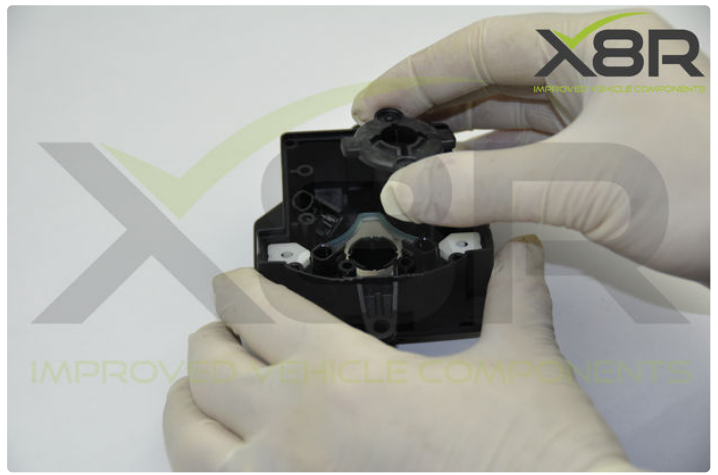
Step 12: Remove Black Plastic Section

Remove black plastic section as shown.

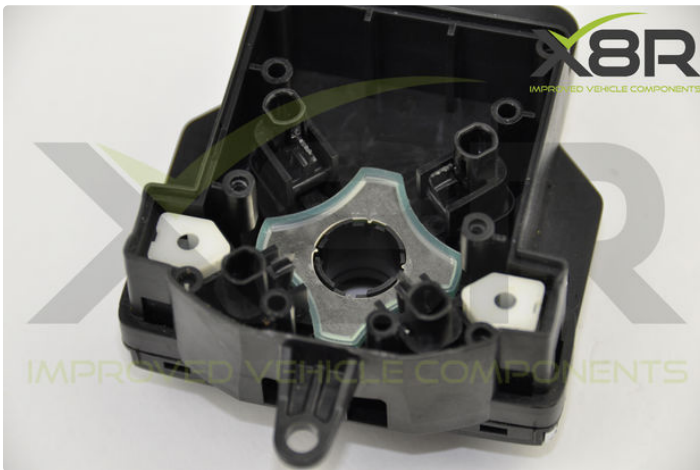
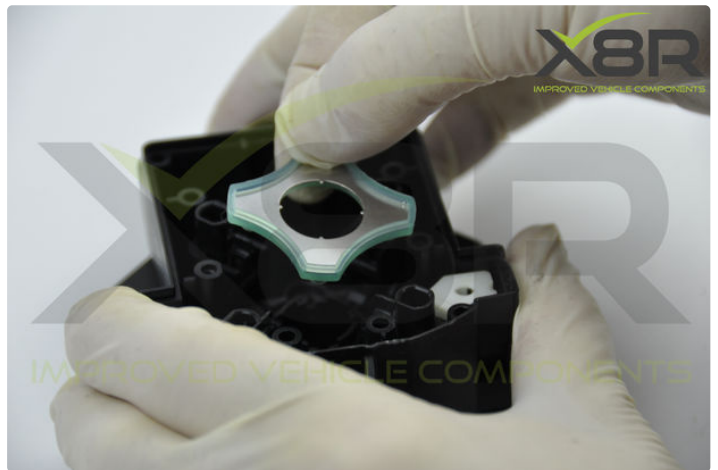
Step 13: Remove Metallic Bush

Remove the metallic bush as shown.

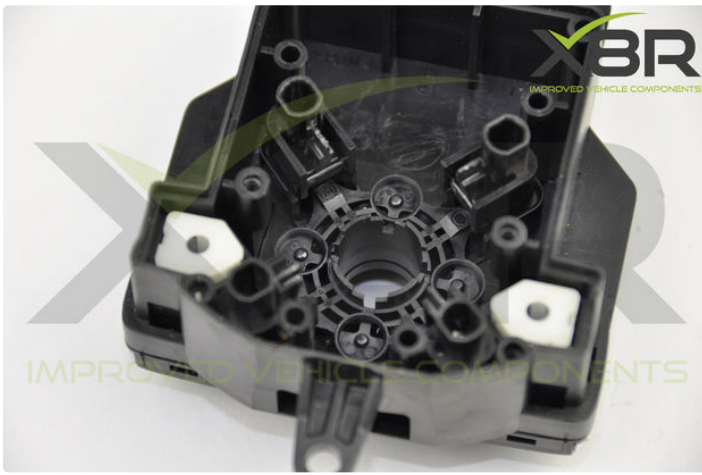
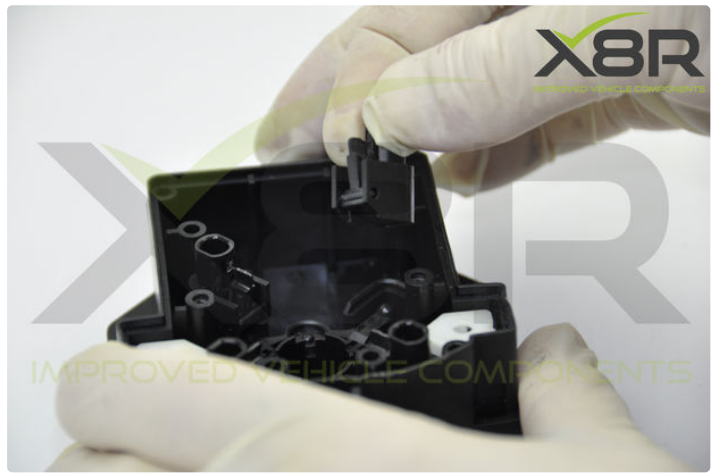
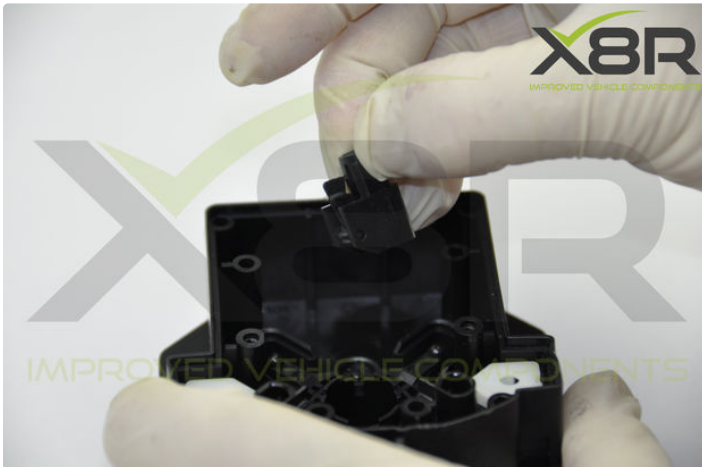
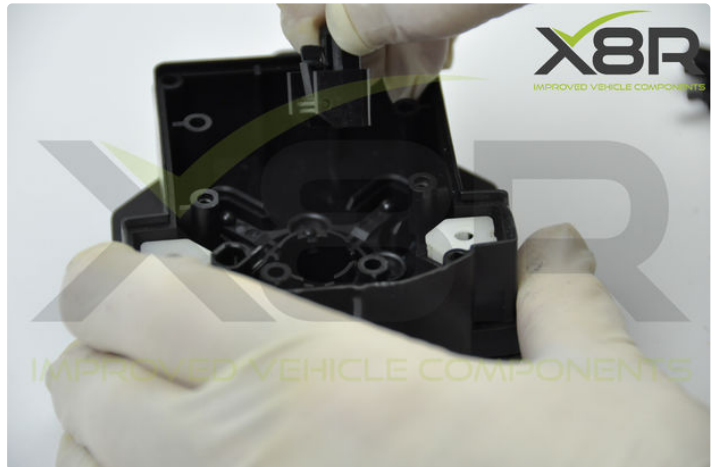
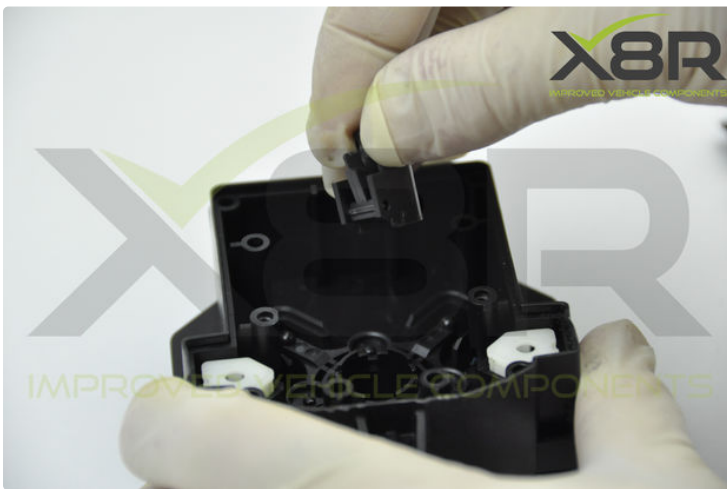
Step 14: Remove All Lower Plastic Parts

Remove all the lower plastic parts as shown.

Sometimes by now these are all in a mess, remove all these loose black plastic parts.

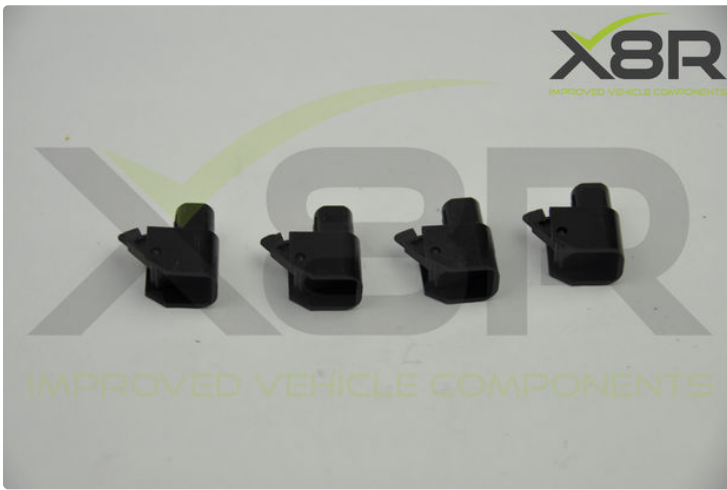
Step 15: Rebuilt 4x Plastic Parts

These 4 black plastic parts here are key for reinstall.

Each of these 4 parts is made of 2 pieces of plastic, often these can become separated. Rebuild these so you have these 4 parts shown orientated as shown.

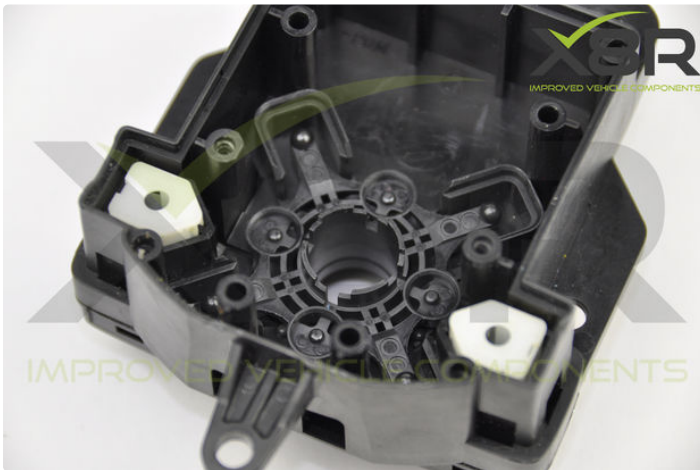
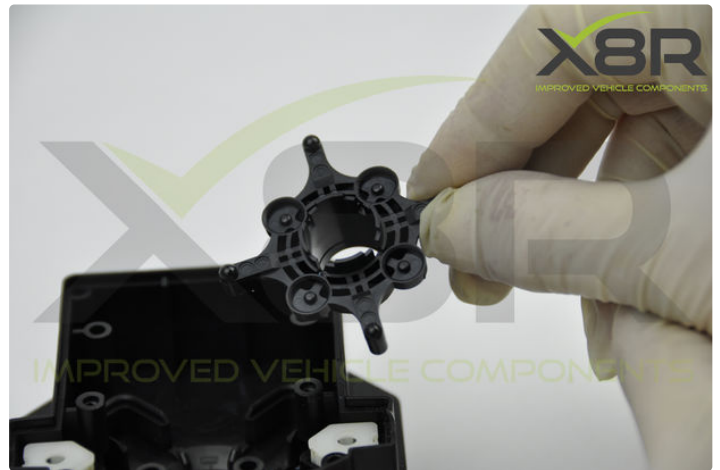
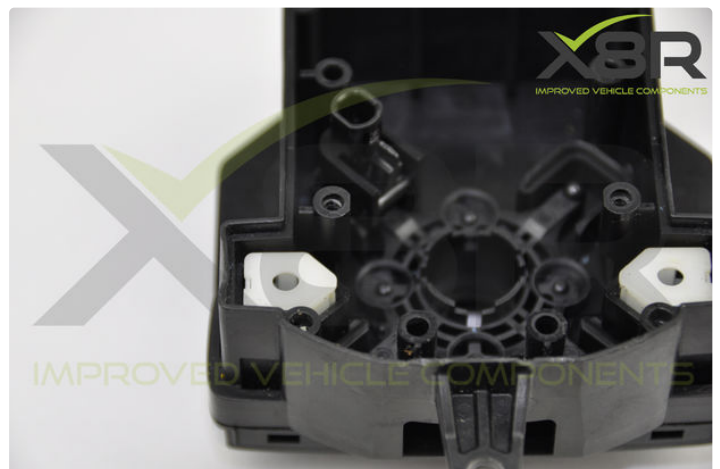
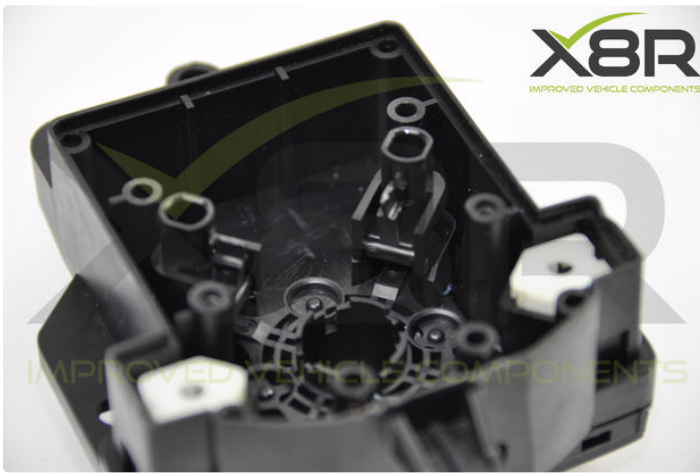
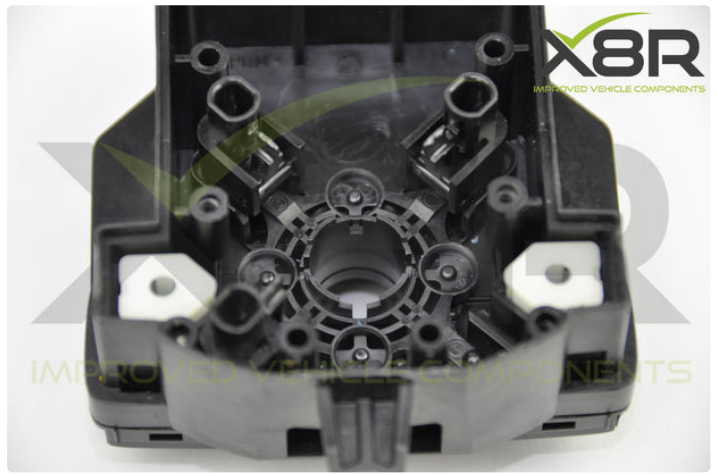
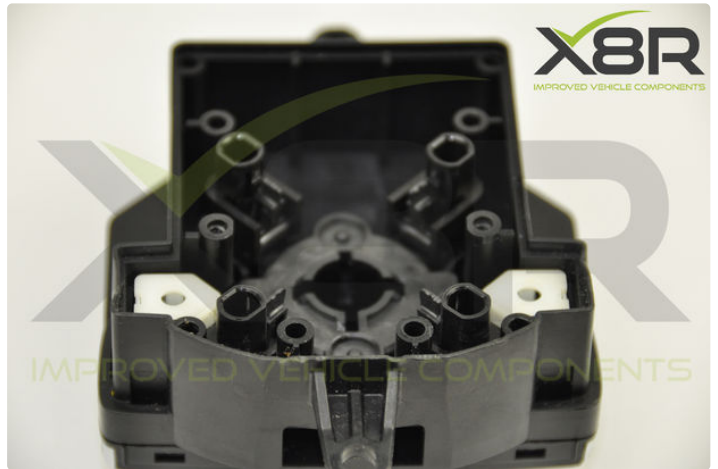
Step 16: Reinstall Lower Black Plastic Parts

Reinstall the base plastic part as shown.

Refit the 4x plastic parts on to each "leg" of the base plastic part as shown.

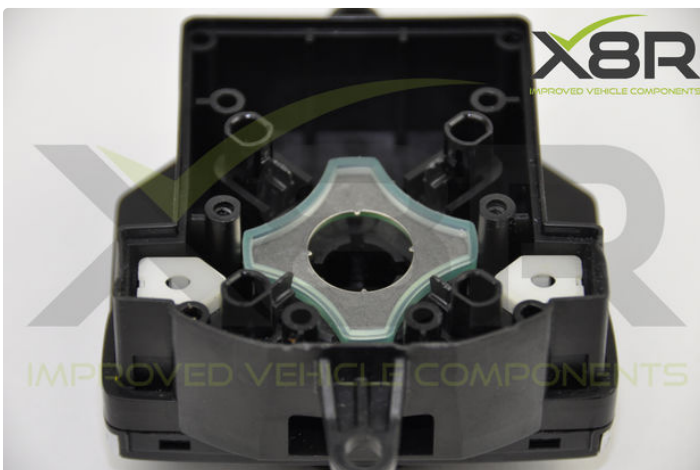
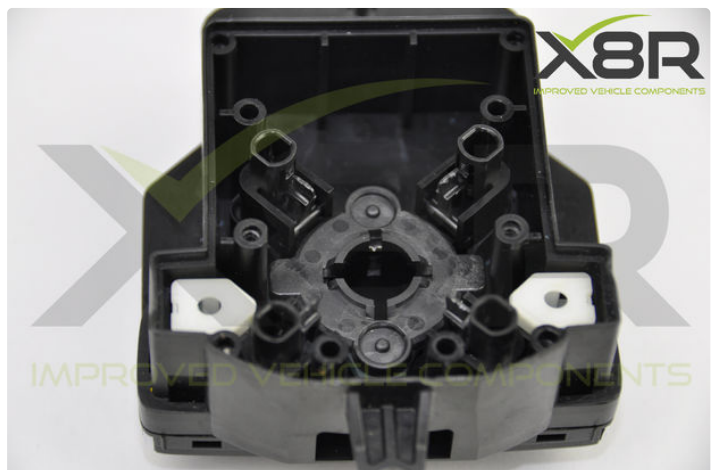
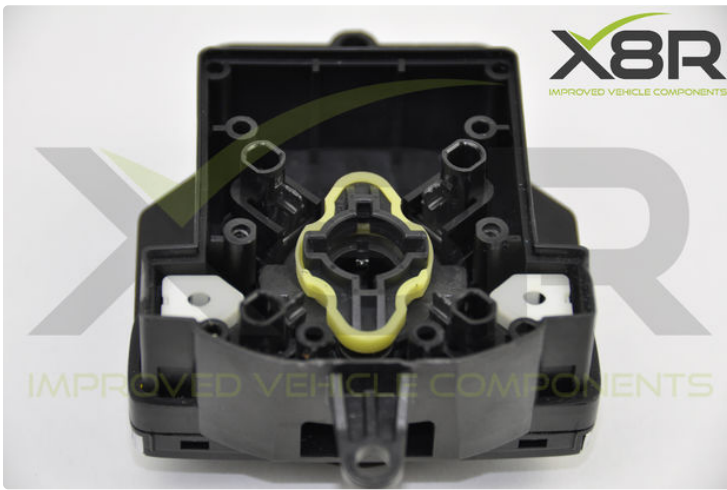
Step 17: Refit Components

Refit metallic bush.

Refit plastic section.

Refit plastic bush.

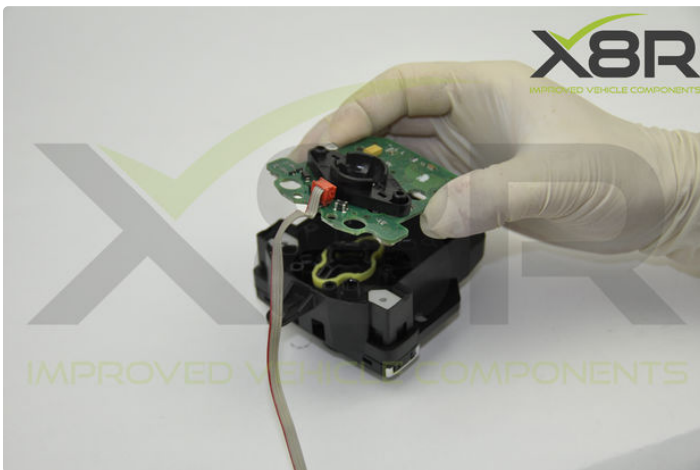
Step 18: Refit the Circuit Board.

The circuit board can be lowered back in to position.

This locates on the 4x lower plastic parts, it is important to ensure when fitting the PCB that these plastic parts do not move and bind.

Using the T10 screwdriver refit the 4x screws.

Check at this stage that the 4x plastic parts haven't moved and gone rigid. Wiggle these parts with the screwdriver to ensure these parts can still be moved a little left to right and up and down. If you cannot move these, remove the PCB and re-seat these parts. This step is very important.

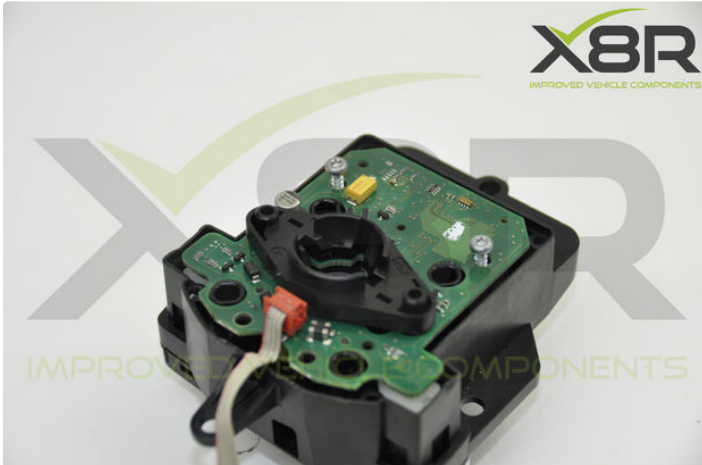
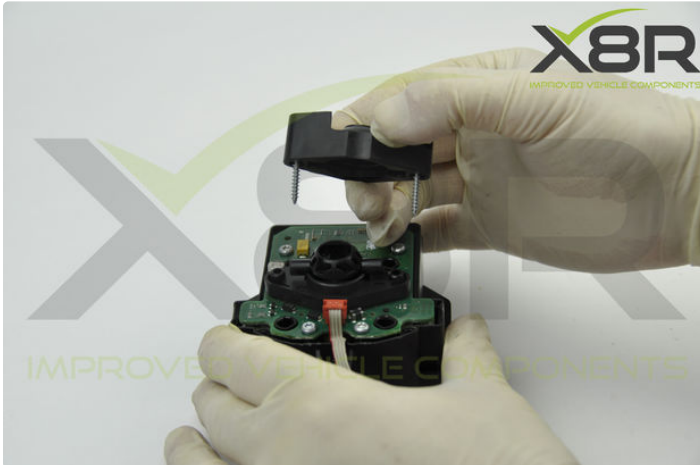
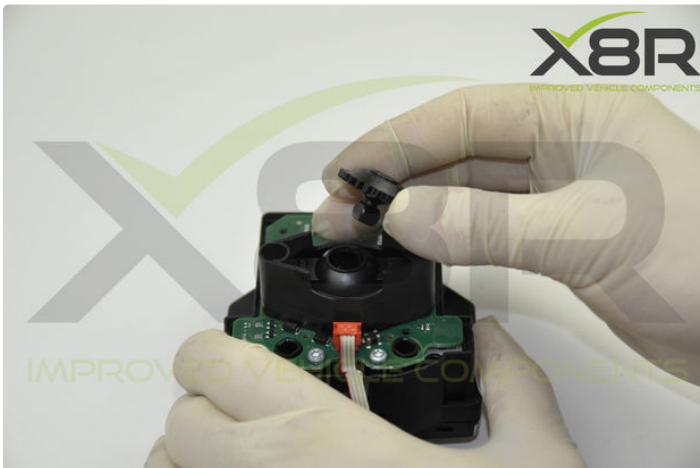
Step 19: Insert Our Spindle and Refit Shaft

Insert our new spindle in to the shaft as shown.

Refit the shaft and tighten the 2x screws.

Refit the top black plastic gear.

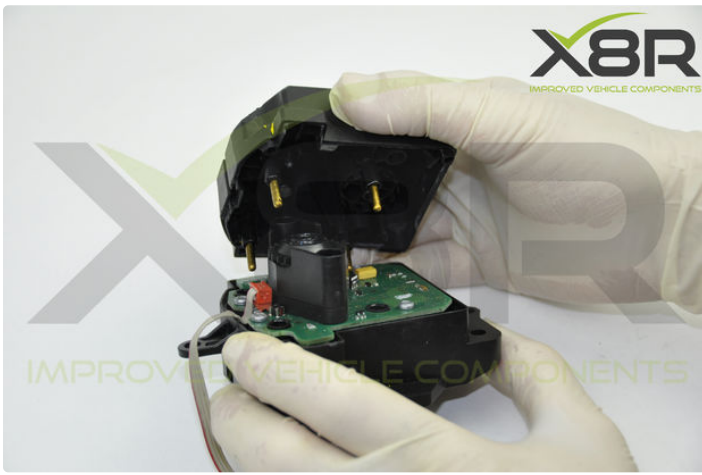
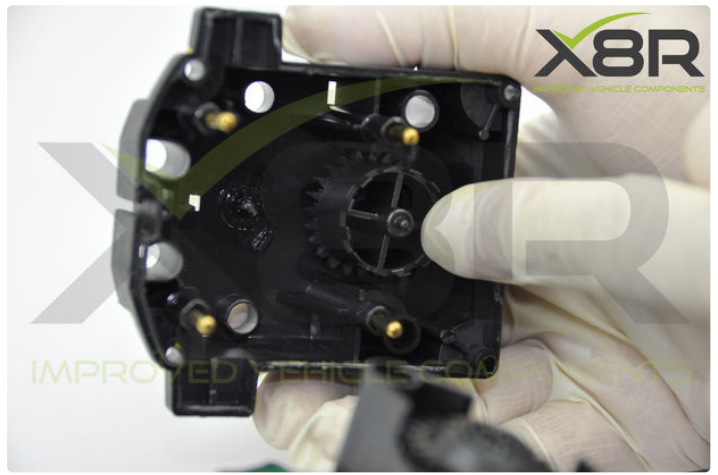
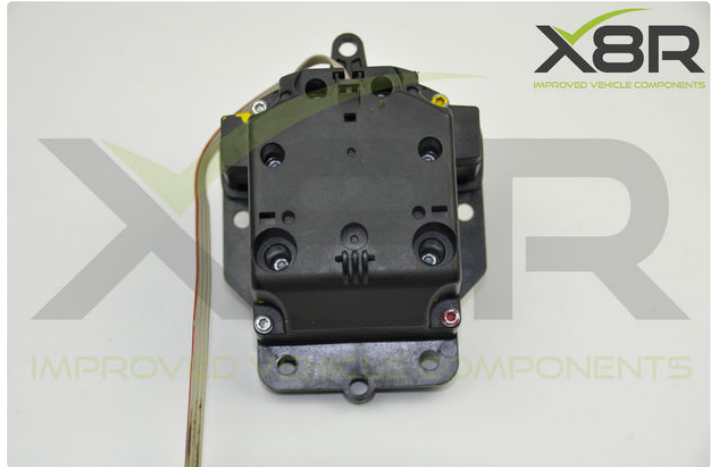
Step 20: Fasten the Two Halves of the Unit Back Together

Refit the two halves of the unit back together, ensuring the gear shown is fitted and orientated correctly.

The pins from the lower section of the housing push in to the x4 black plastic parts, again ensure these have not moved as this will make refitting the two halves very difficult.

Re-fasten the 4x screws.

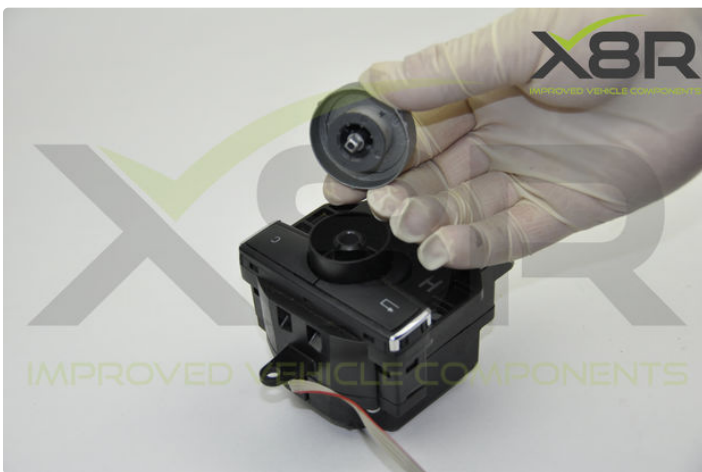
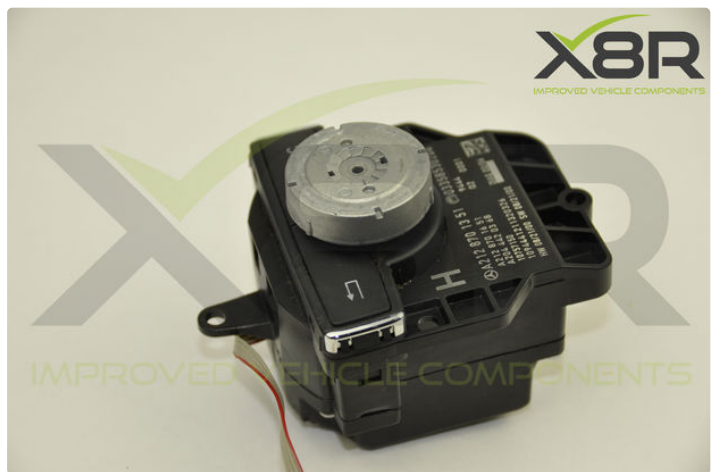
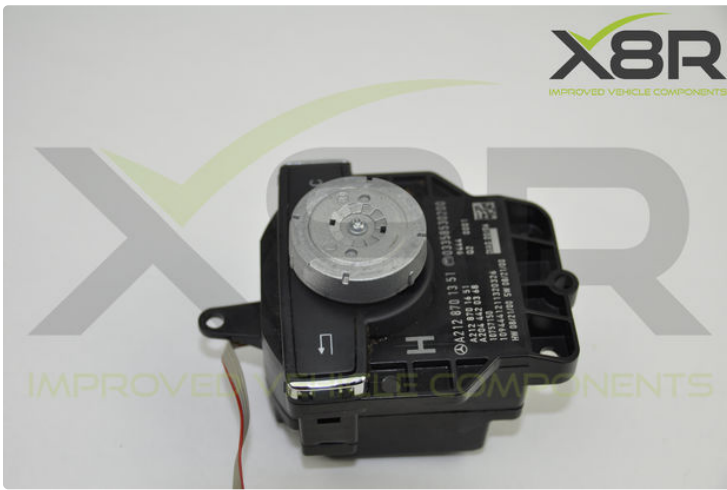
Step 21: Refit the Top Dial

Refit the top dial.

Re-tighten the screw, you may need to push down on the dial for this to fasten.

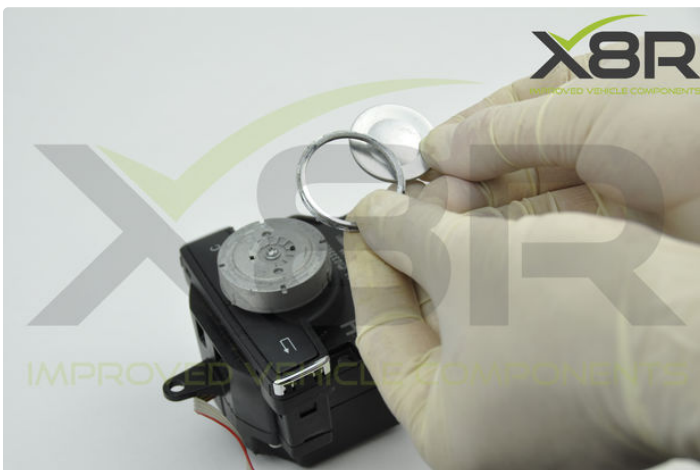
Step 22: Refit Top Button and Outer Ring

Refit the top button in to the outer ring and push on to the dial.

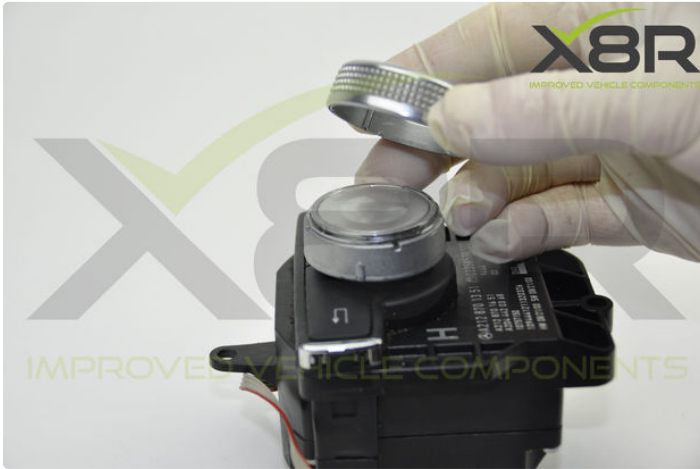
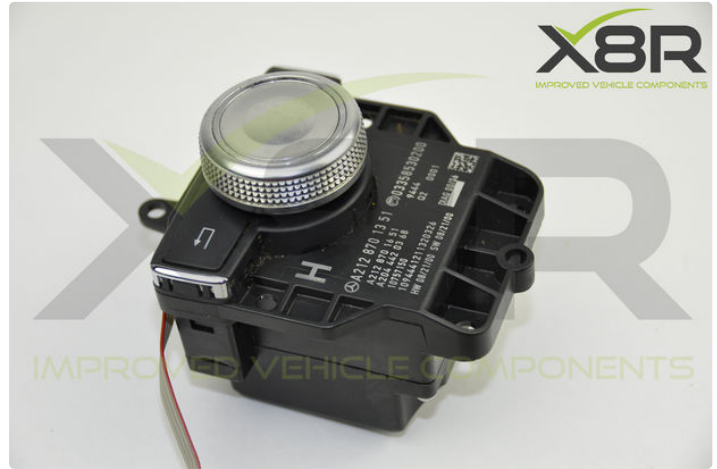
Step 23: Refit the Outer Section

Note where this section locates on the dial and push in to position.
