# Audi Seat Skoda VW 2.7 & 3.0 TDI Left & Right Intake Inlet Intake Manifold P2015 Error Motor Actuator Repair Bracket Fix Kit Install Instructions Guide

by x8rltd

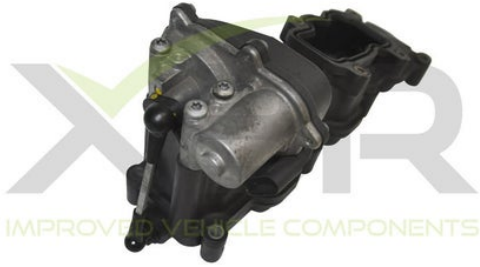
### **Complete Kit**

2x Stainless steel brackets to fit both Left and Right hand manifolds. (4 and 5 pin)

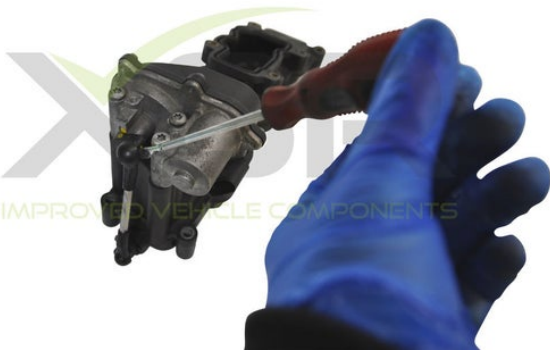
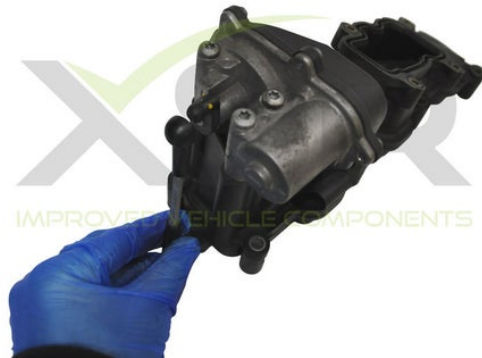
### Step 1: Remove Linkage Arm

**This repair can normally be carried out in situ on the vehicle but is shown here on the bench for clarity.**

Using a flat bladed screwdriver lever the linkage arm away from the ball joint on the actuator.

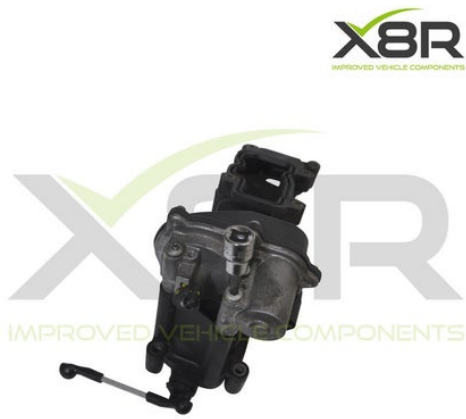
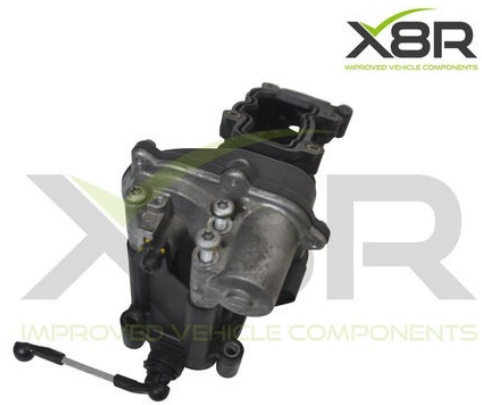
### Step 2: Remove Actuator Screws

Using a T30 bit remove the 2x actuator screws shown.

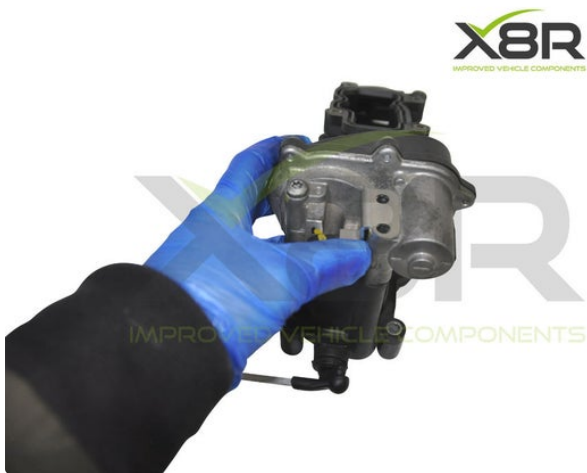
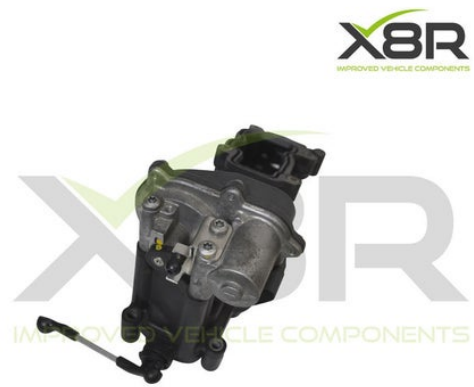
### Step 3: Fit Our Bracket

Select the correct bracket from our set and fit as shown. You will need to rotate the actuator by hand by pushing on the ball joint, hold this under tension, you can then slide our bracket in to place, line up the holes in the top section to the actuator holes and re-tighten the screws.

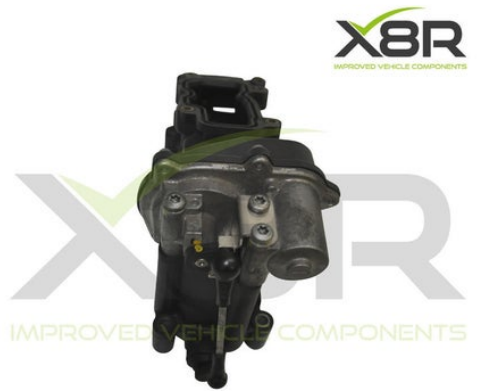
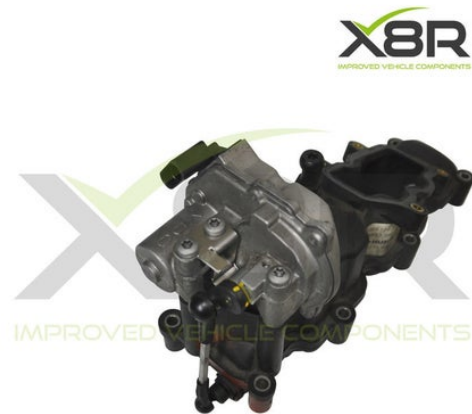
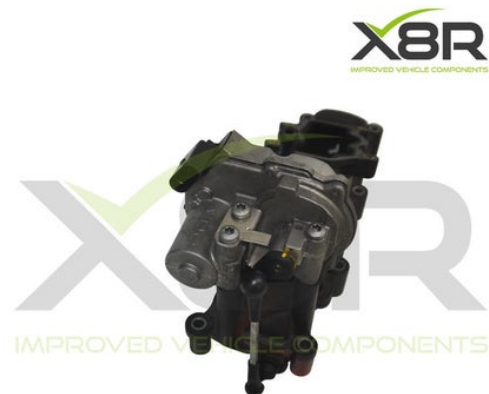
### Step 4: Refit Linkage

Push fit linkage on to the actuator ball joint.

You can then test the movement of the actuator motor and see that it tops and bottoms out on our bracket, keeping it within range.
